DEXTER COMMUNITY SCHOOLS

2023 ROOF EVALUATION

RTA PROJECT NO. 22-106

APRIL 7, 2023

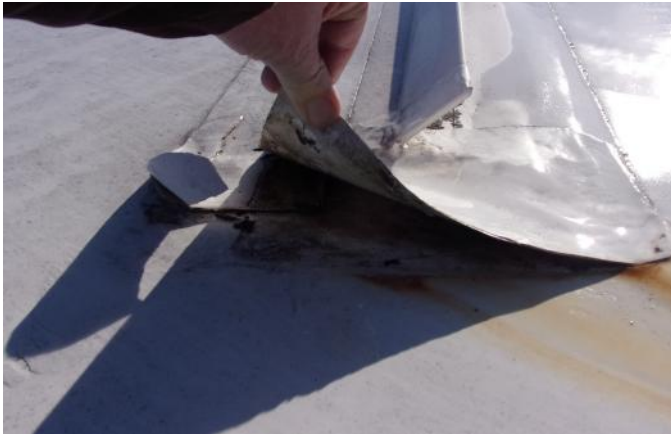
Photo 13
Dexter High School
February 2023

Area C: Loose stripping material at diverter

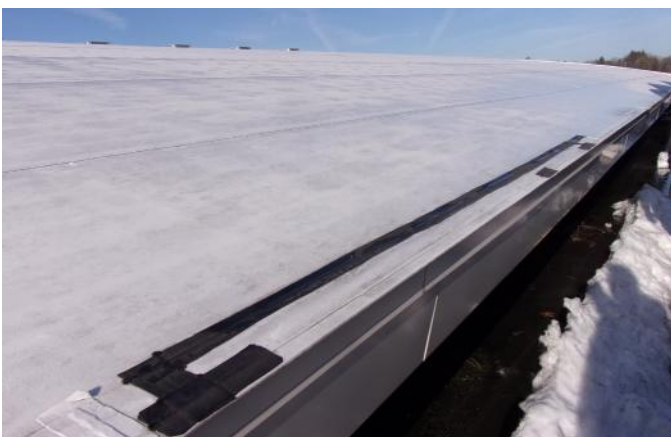
Photo 16
Dexter High School
February 2023

Area C: Repairs at eave/edge metal stripping

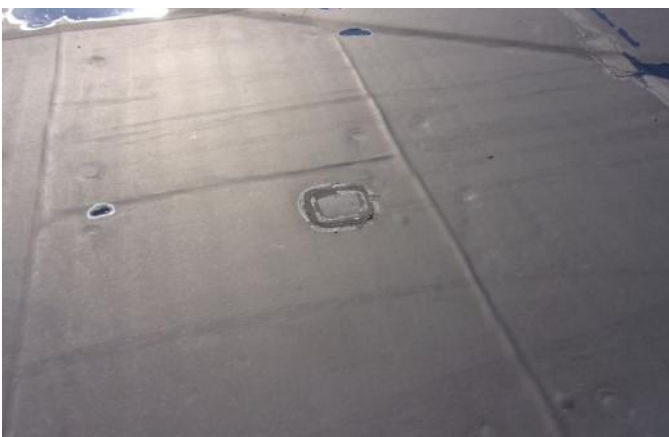
Photo 25
Dexter High School
February 2023

Area G: Repairs

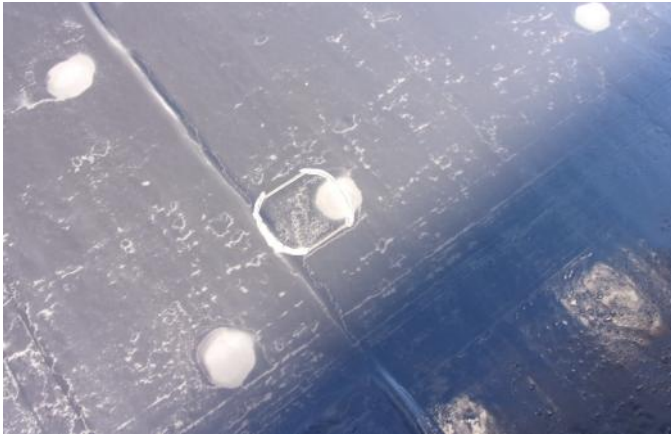
Photo 29
Dexter High School
February 2023

Area G: Repairs

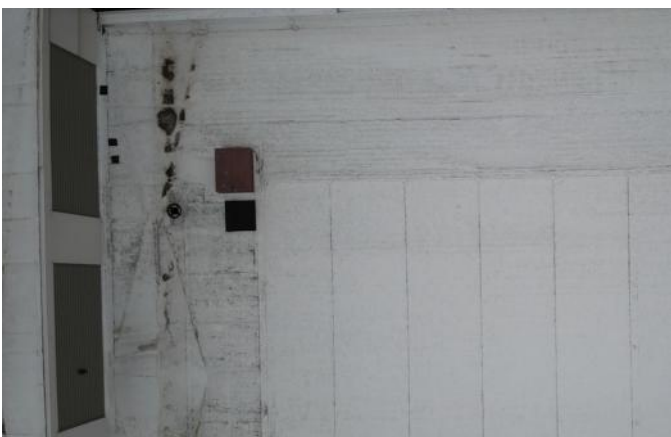
Photo 36
Dexter High School
February 2023

Area I: Missing drain strainer - sediment
stains

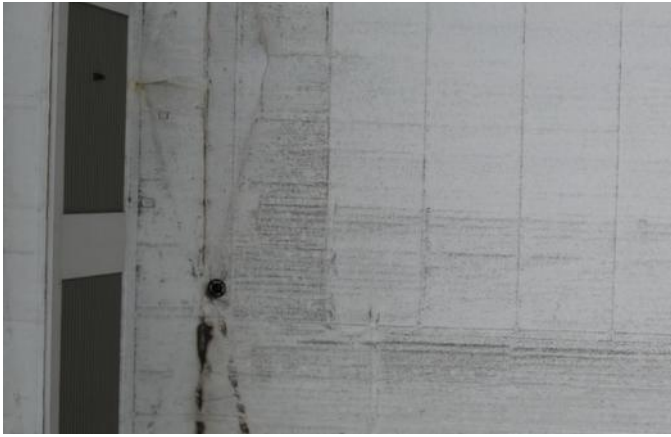
Photo 37
Dexter High School
February 2023

Area I: Missing drain strainer - sediment stains

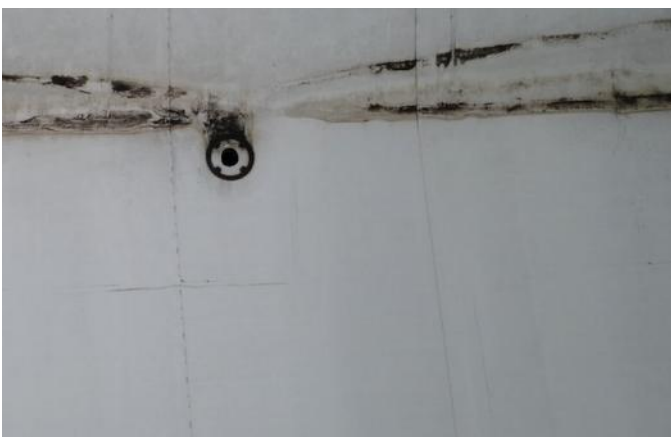
Photo 40
Dexter High School
February 2023

Area J: Missing drain strainer - sediment stains

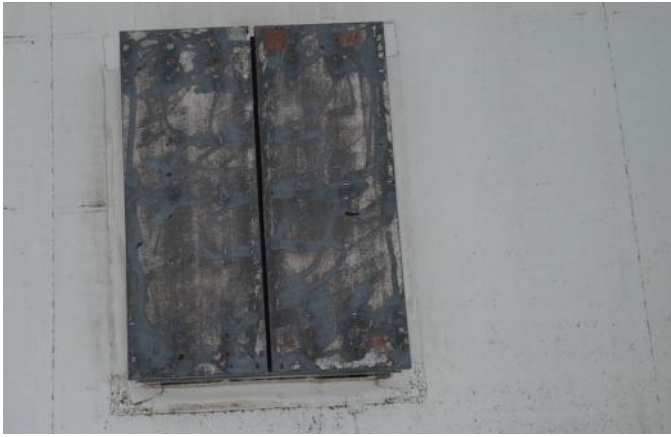
Photo 41
Dexter High School
February 2023

Area J: Smoke release hatches are corroding

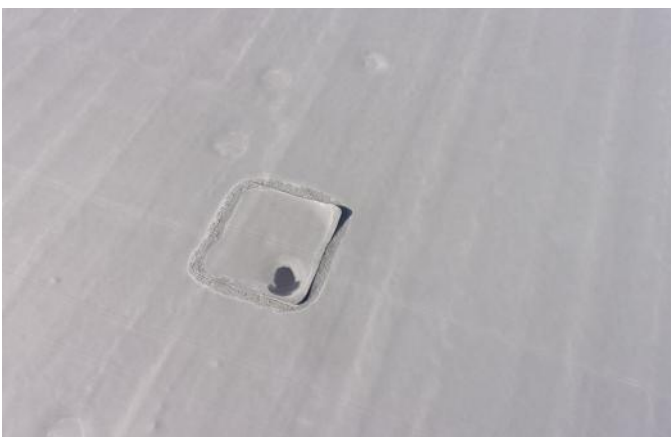
Photo 52
Dexter High School
February 2023

Area N: loose patch seams/failed lap sealant

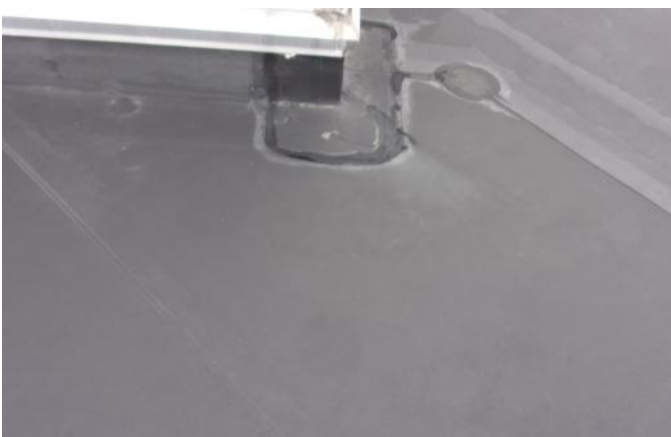
Photo 8
Anchor and Beacon
February 2023

Although many repairs are evident around seams and laps on the older side of the building (Anchor and Beacon Photos 6 through 8), there are loose seams where the lap sealant has failed. Otherwise the typical debris and vegetation was observed on many areas of the roof.

Area A: Repaired lap sealant

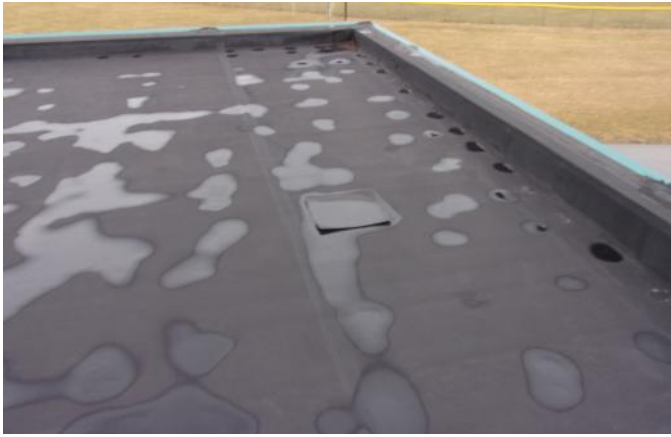
Photo 9
Anchor and Beacon
February 2023

Area A: Loose seams on patch

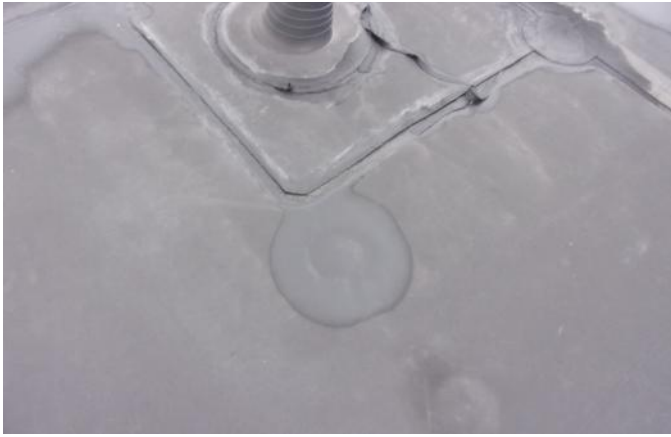
Photo 21
Anchor and Beacon
February 2023

Area E: Loose seams

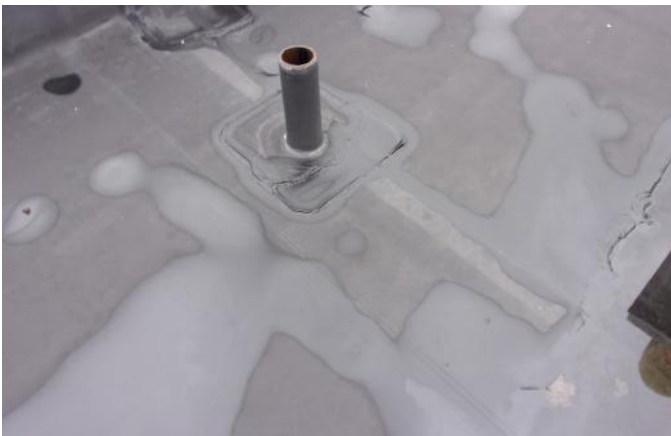
Photo 24
Anchor and Beacon
February 2023

Area E: Loose seams

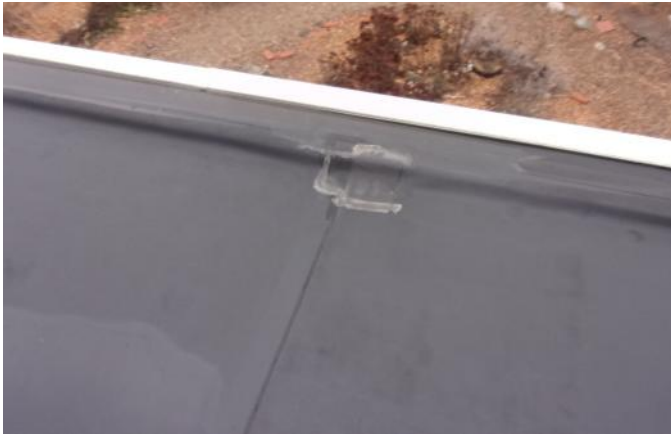
Photo 9
Wylie Elementary School
February 2023

Area D: Repaired seams

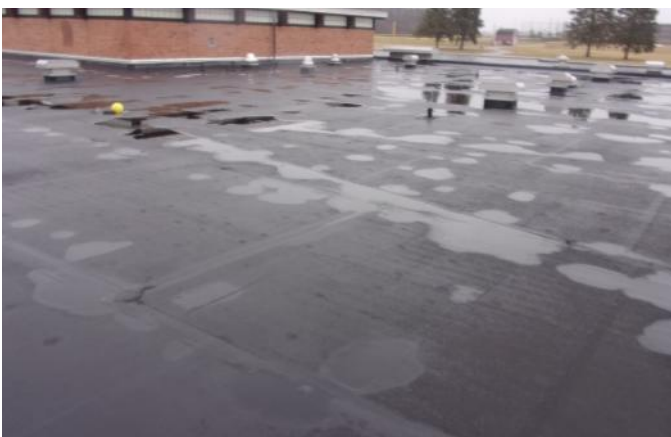
Photo 12
Wylie Elementary School
February 2023

Area D: Ponding

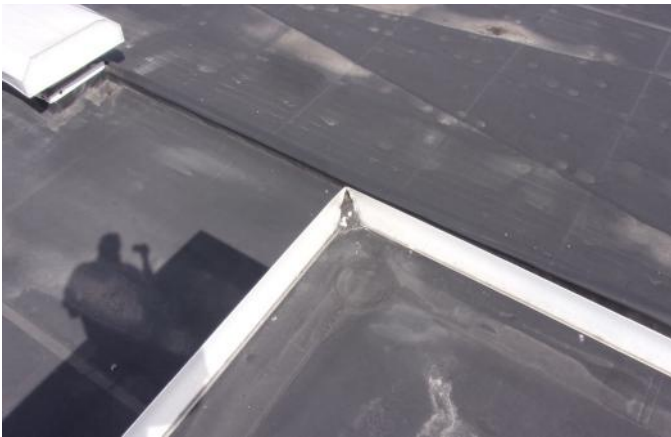
Photo 14
Wylie Elementary School
February 2023

Area E: Repairs to edge metal

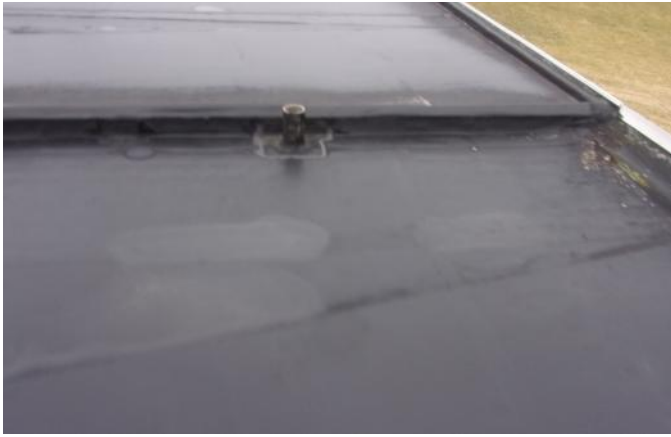
Photo 17
Wylie Elementary School
February 2023

Area G: Repaired seams

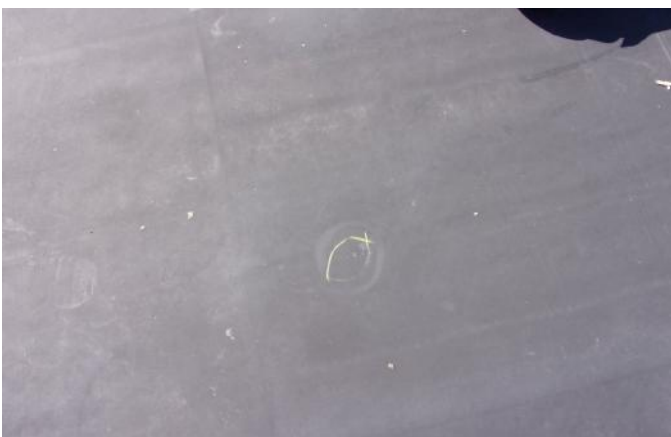
Photo 16
Creekside
February 2023

Area G: Puncture in membrane (repaired
by RTA)

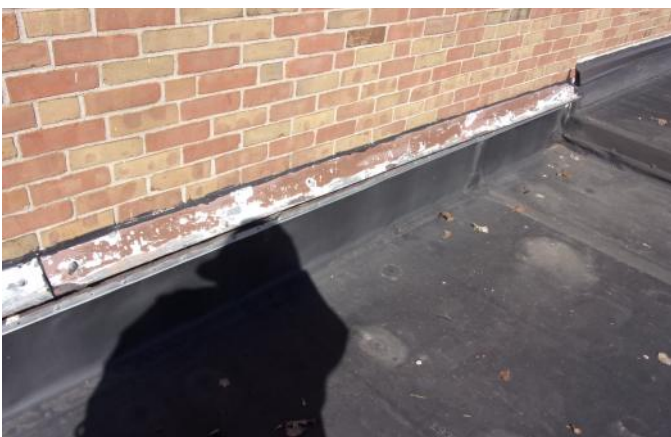
Photo 32
Creekside
February 2023

Area P: Corroding counterflashing

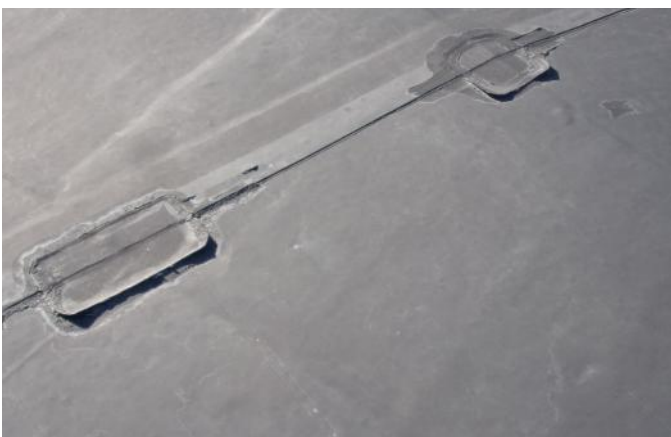
Photo 4
Bates
February 2023

Area A: Failed lap sealant

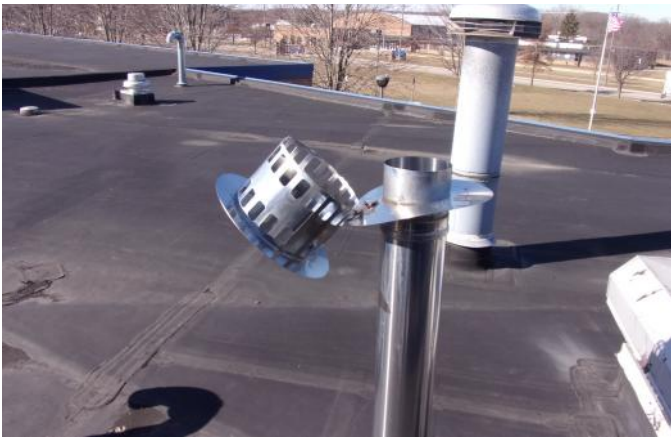
Photo 23
Bates
February 2023

Area F: Damaged stack

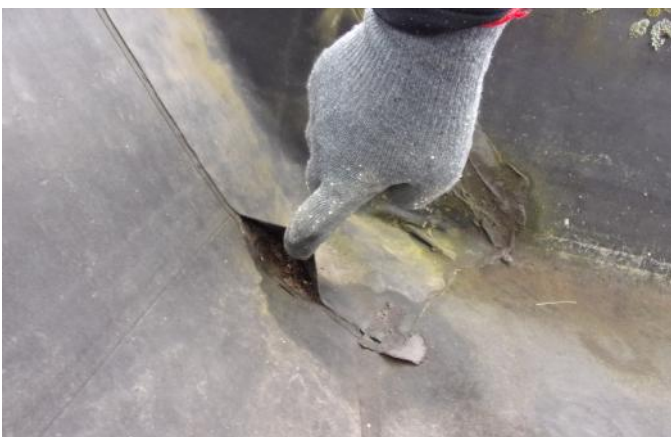
Photo 8
Jenkins
February 2023

Area C: Loose seams

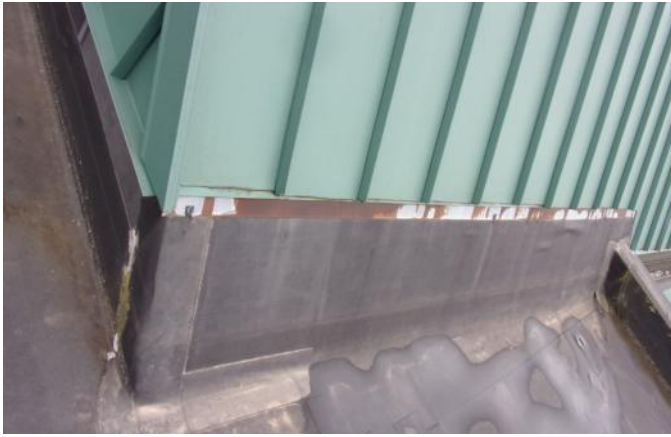
Photo 9
Jenkins
February 2023

Area C: Rust/corrosion on counterflashing

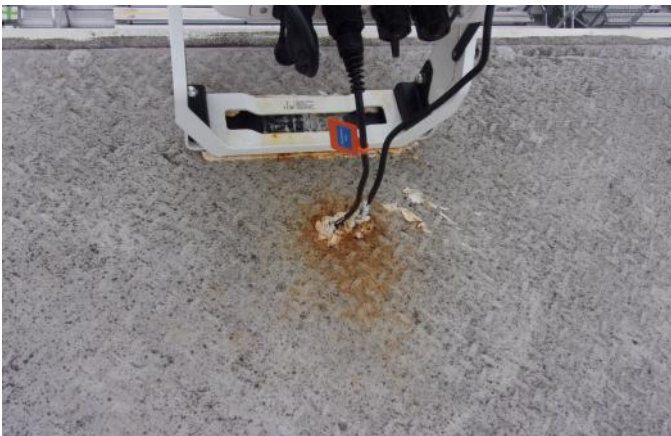
Photo 4
Al Ritt Field
February 2023

Press Box Roof: Improperly flashed penetrations
