DEXTER COMMUNITY SCHOOLS

2023 ROOF EVALUATION

RTA PROJECT NO. 22-106

APRIL 7, 2023

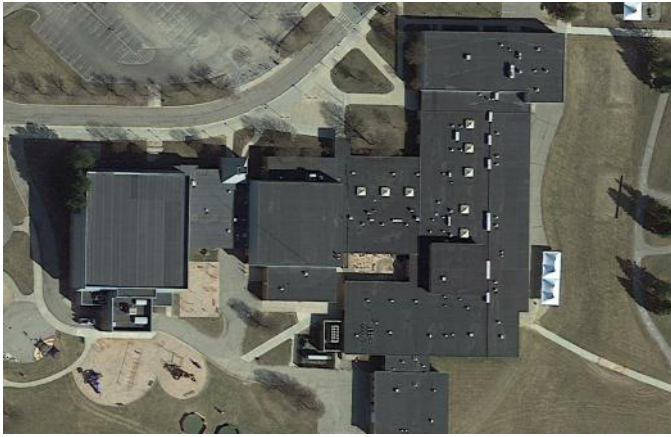
Photo 1
Wylie Elementary School
February 2023

Wylie Elementary School Aerial View

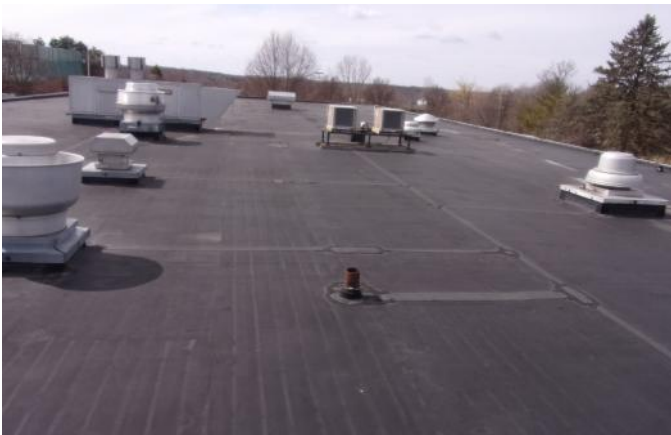
Photo 2
Wylie Elementary School
February 2023

Area A: Overview

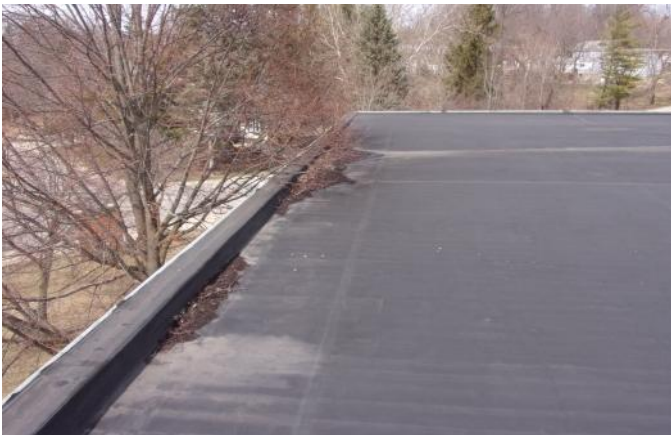
Photo 3
Wylie Elementary School
February 2023

Area A: Branches overhanging the roof -
leaves accumulating

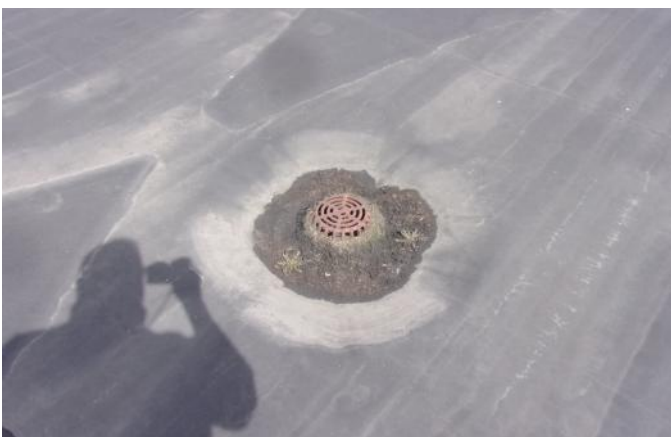
Photo 4
Wylie Elementary School
February 2023

Area A: Leaves/debris in drain

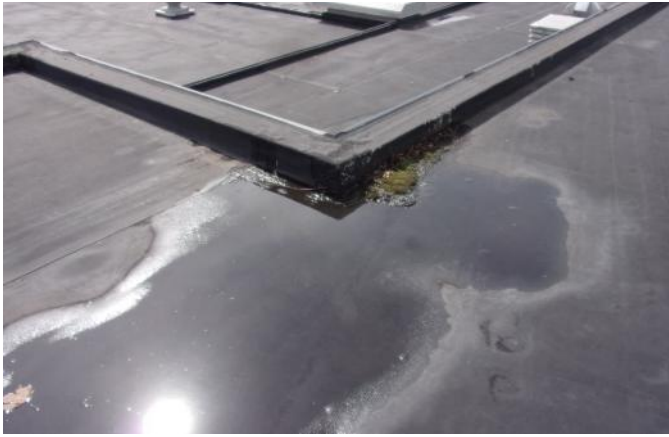
Photo 5
Wylie Elementary School
February 2023

Area A: Ponding/vegetation

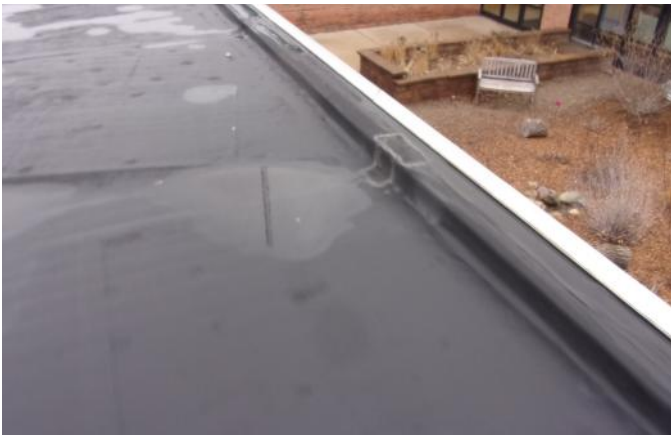
Photo 10
Wylie Elementary School
February 2023

Area D: Repaired seams

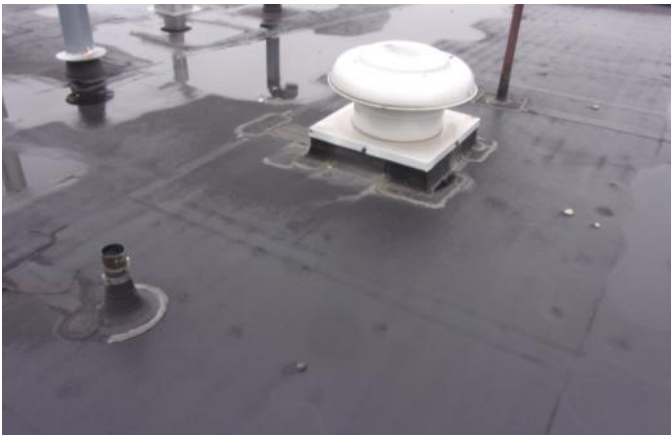
Photo 11
Wylie Elementary School
February 2023

Area D: Repaired seams/ponding

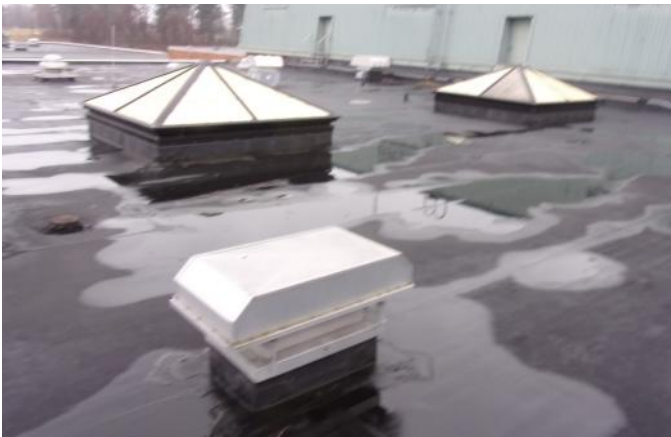
Photo 18
Wylie Elementary School
February 2023

Area H: Overview

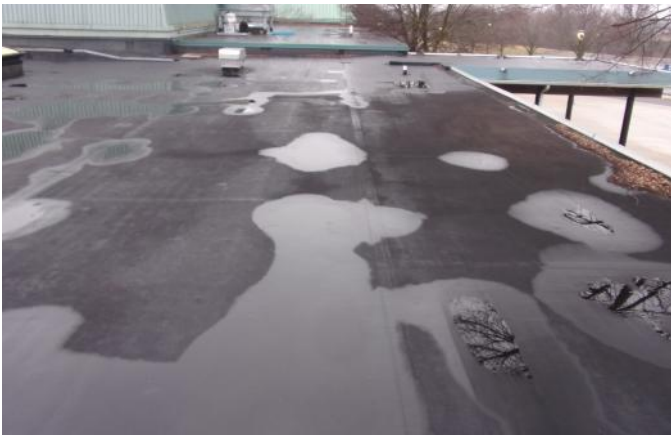
Photo 19
Wylie Elementary School
February 2023

Area H: Ponding

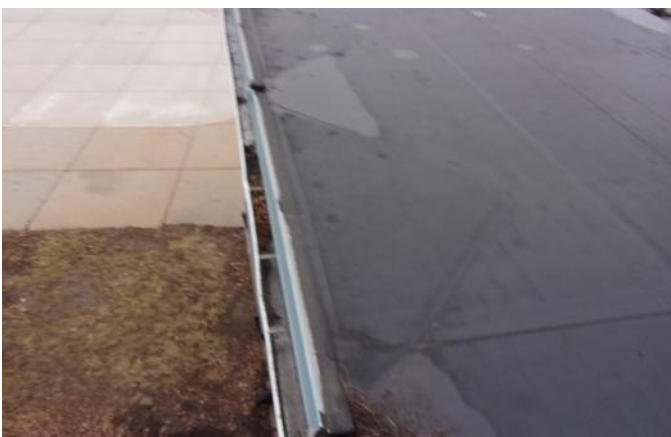
Photo 20
Wylie Elementary School
February 2023

Area I: Leaves in gutter

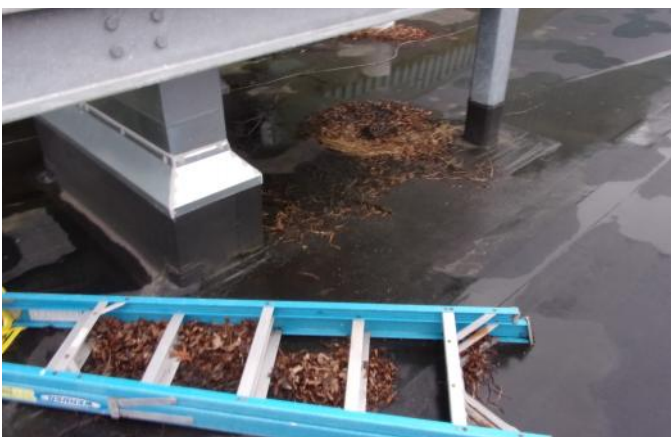
Photo 24
Wylie Elementary School
February 2023

Area L: Foreign object on roof membrane
- leaves in drain strainer

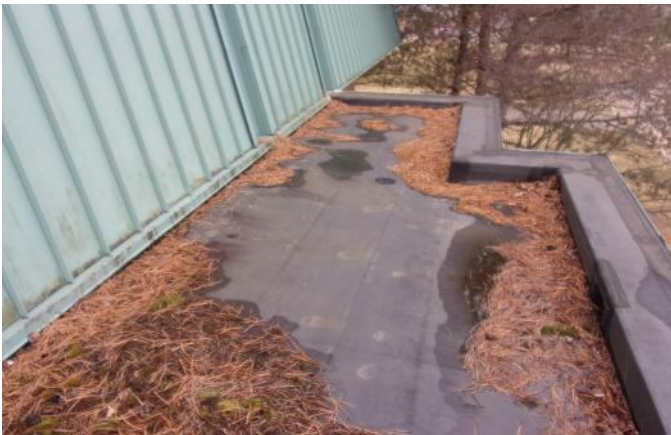
Photo 27
Wylie Elementary School
February 2023

Area N: Leaves/debris

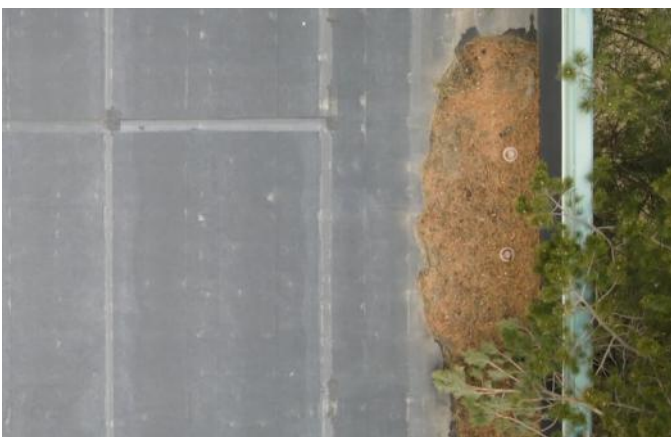
Photo 32
Wylie Elementary School
February 2023

Area S: Overhanging branches - leaves in drains

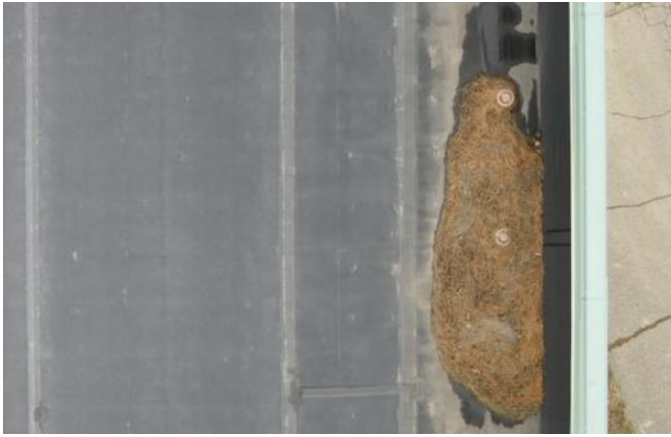
Photo 33
Wylie Elementary School
February 2023

Area S: Overhanging branches - leaves in drains
