DEXTER COMMUNITY SCHOOLS

2023 ROOF EVALUATION

RTA PROJECT NO. 22-106

APRIL 7, 2023

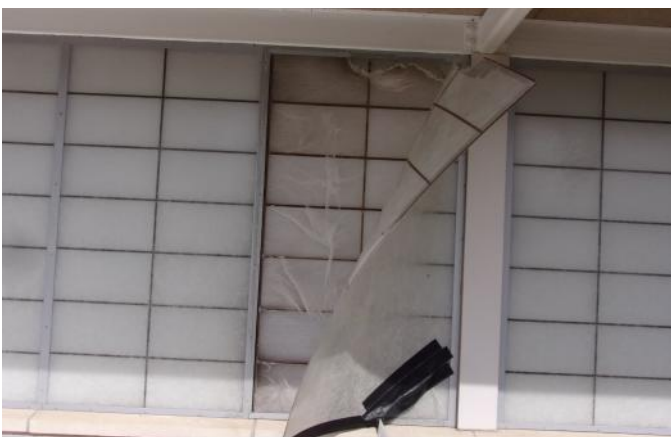
Photo 8
Dexter High School
February 2023

Area A3: Displaced wall panel

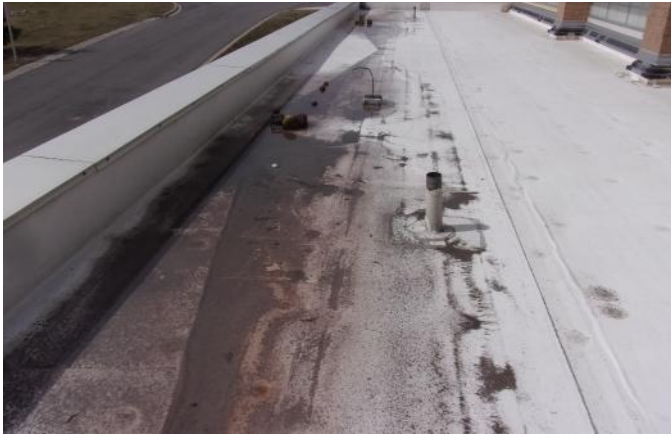
Photo 9
Dexter High School
February 2023

Area A3: Ponding and sediment

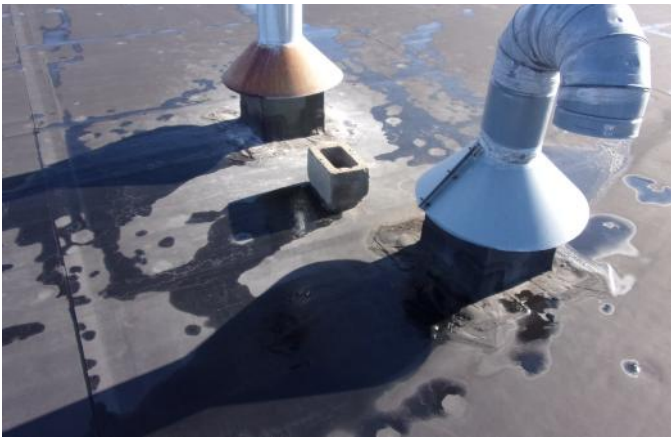
Photo 11
Dexter High School
February 2023

Area B: Foreign object on the roof
membrane

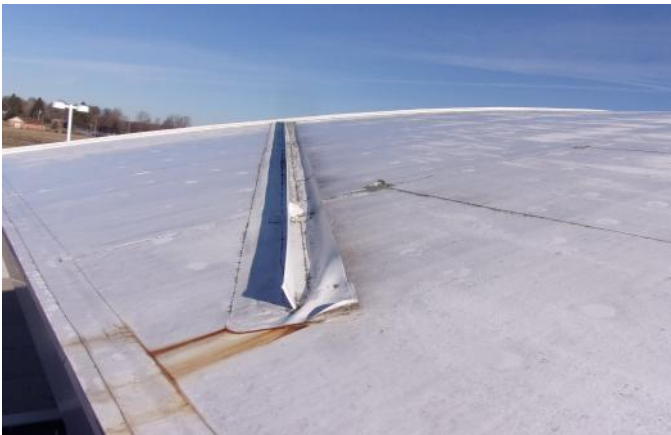
Photo 14
Dexter High School
February 2023

Area C: Loose stripping material at diverter

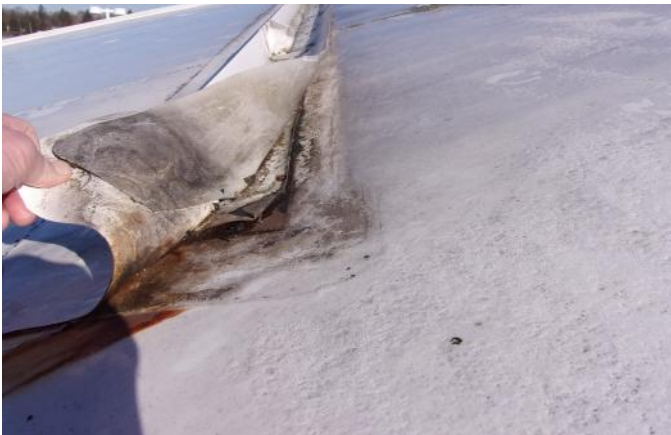
Photo 15
Dexter High School
February 2023

Area C: Loose stripping material at diverter

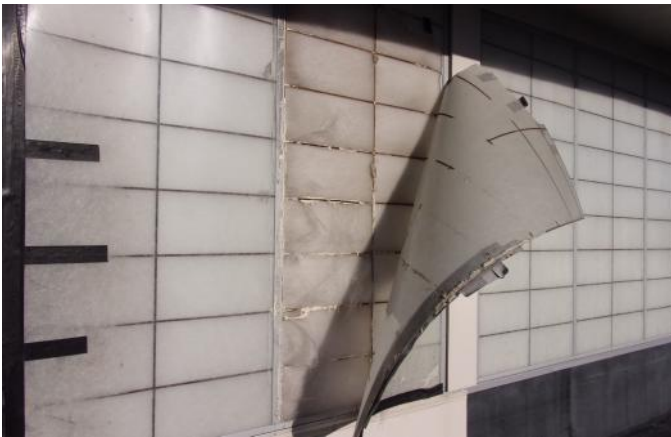
Photo 19
Dexter High School
February 2023

Area D: Displaced wall panel

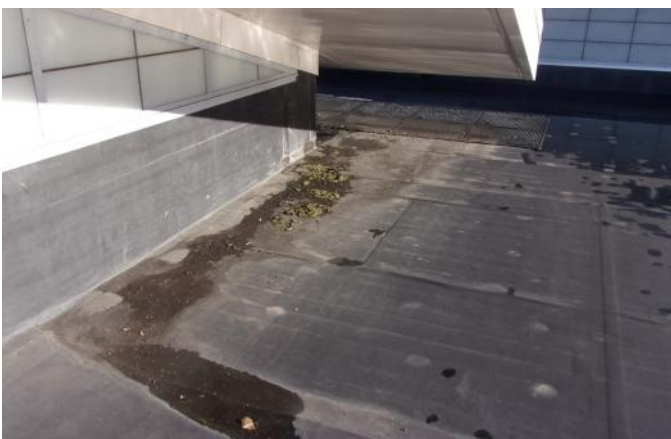
Photo 20
Dexter High School
February 2023

Area D: Vegetation/evidence of long-term
ponding

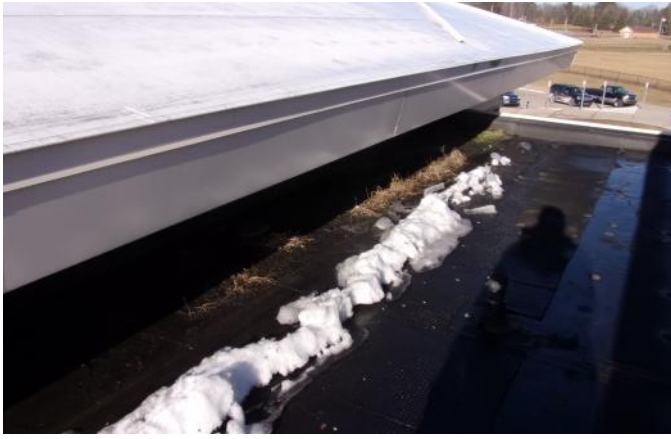
Photo 21
Dexter High School
February 2023

Area D: Vegetation/evidence of long-term ponding

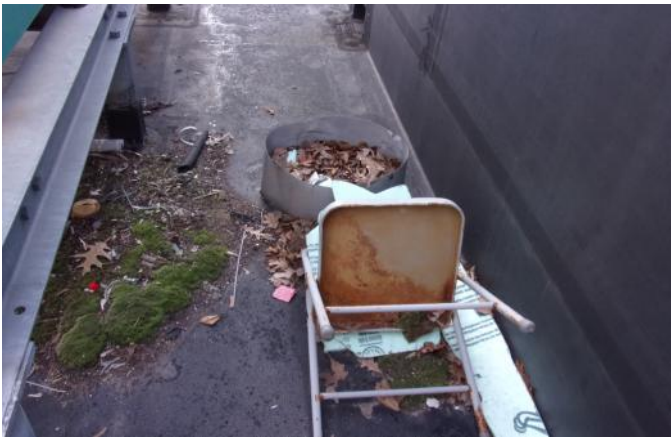
Photo 23
Dexter High School
February 2023

Area E: Vegetation/debris - foreign object on the roof membrane

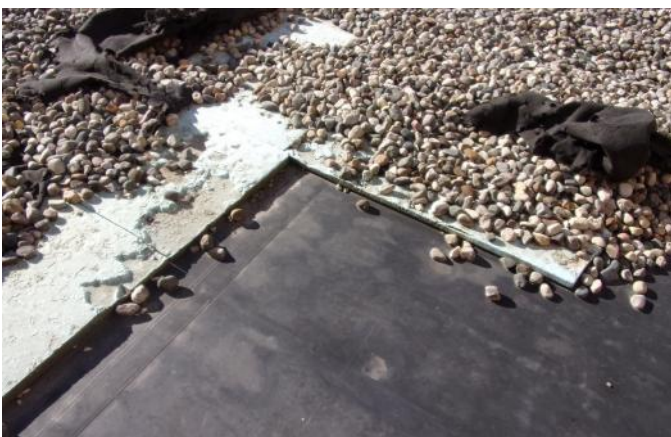
Photo 32
Dexter High School
February 2023

Area H: Displaced ballast stone,
permeable fabric and insulation board

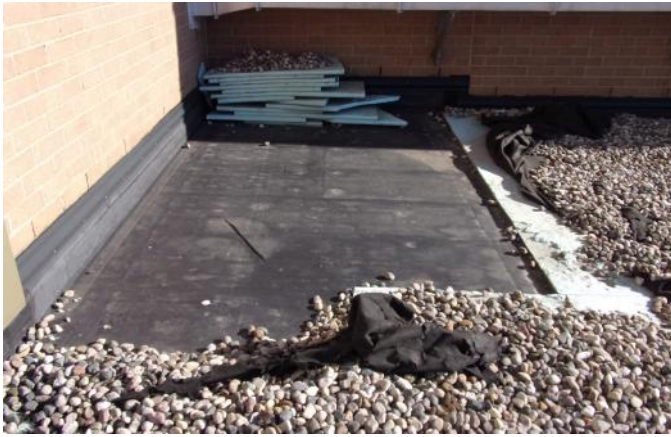
Photo 33
Dexter High School
February 2023

Area H: Displaced ballast stone,
permeable fabric and insulation board

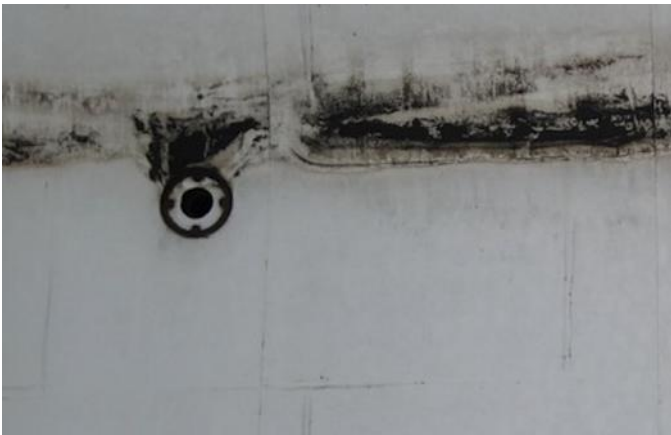
Photo 39
Dexter High School
February 2023

Area J: Missing drain strainer - sediment stains

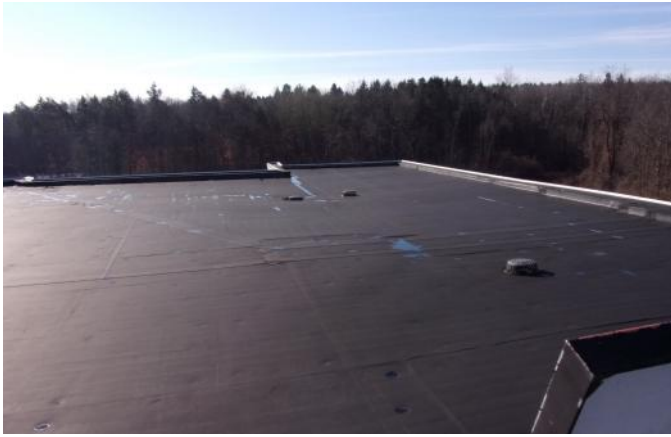
Photo 49
Dexter High School
February 2023

Area N: Overview

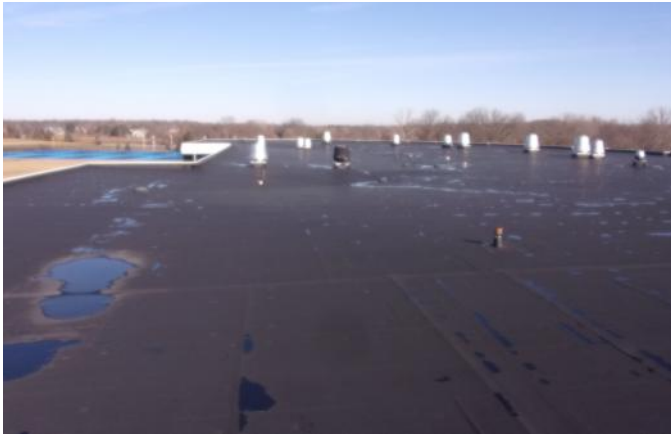
Photo 53
Dexter High School
February 2023

Area N1: Overview

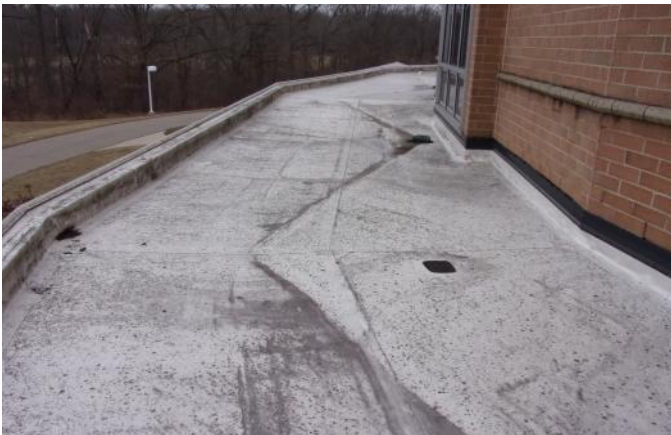
Photo 59
Dexter High School
February 2023

Area P: Overview

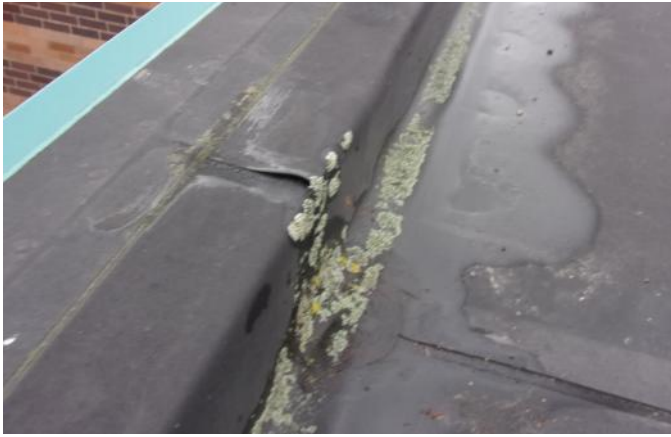
Photo 5
Anchor and Beacon
February 2023

Area A: Vegetation/open lap seam

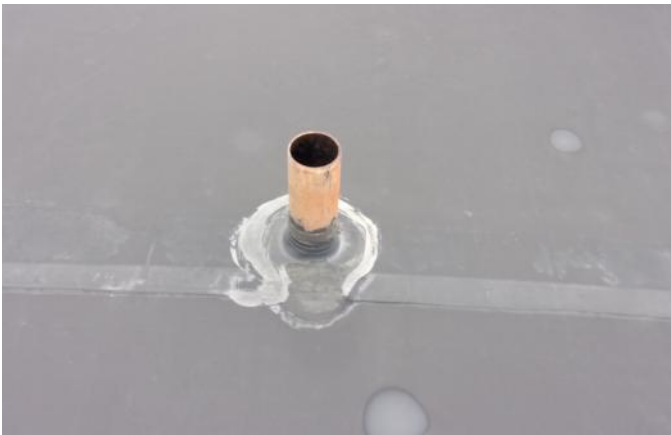
Photo 6
Anchor and Beacon
February 2023

Although many repairs are evident around seams and laps on the older side of the building (Anchor and Beacon Photos 6 through 8), there are loose seams where the lap sealant has failed. Otherwise the typical debris and vegetation was observed on many areas of the roof.

Area A: Repaired lap sealant

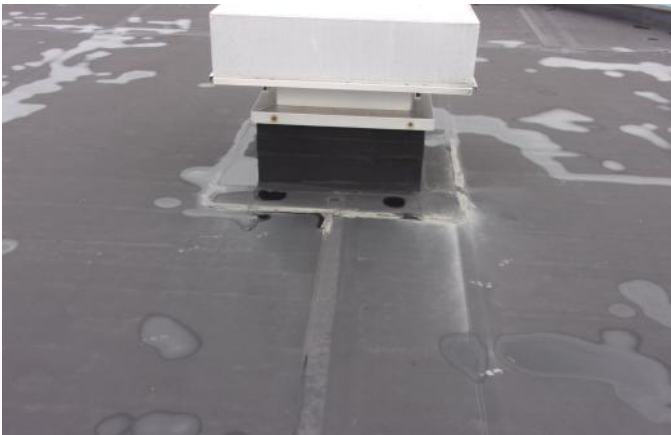
Photo 7
Anchor and Beacon
February 2023

Area A: Repaired lap sealant

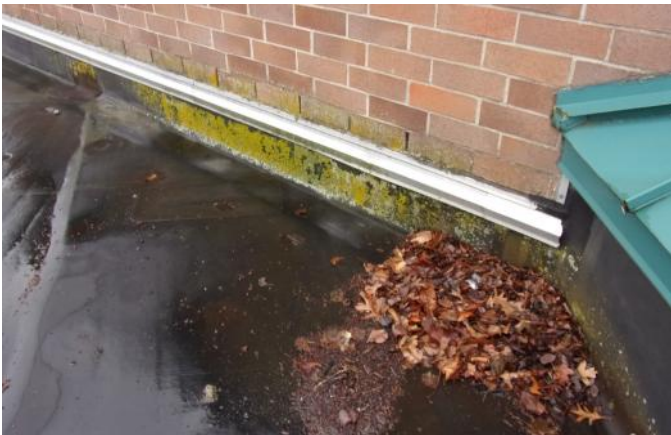
Photo 10
Anchor and Beacon
February 2023

Area A: Vegetation

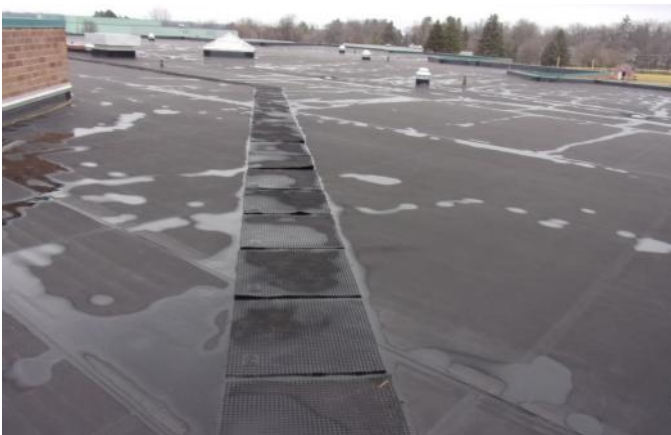
Photo 11
Anchor and Beacon
February 2023

Area A: Walk pads are curling up at corners

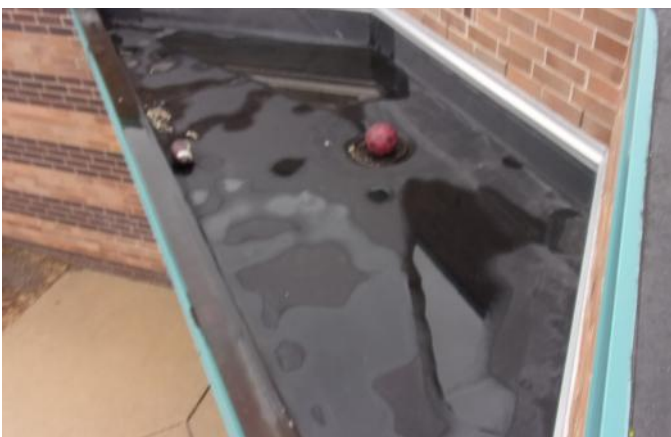
Photo 12
Anchor and Beacon
February 2023

Area A1: Overview - foreign objects on roof - blocked drain

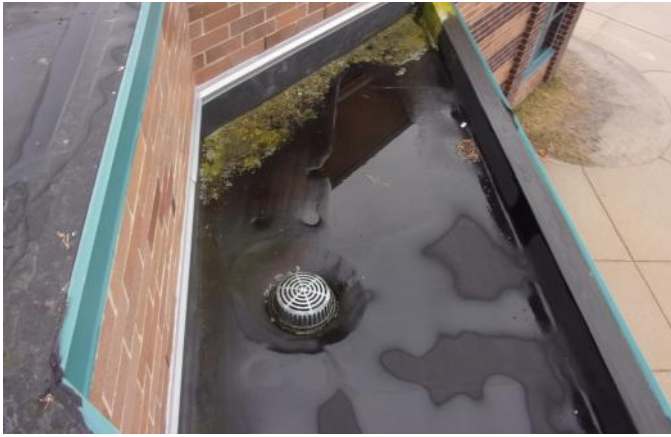
Photo 13
Anchor and Beacon
February 2023

Area A3: Vegetation

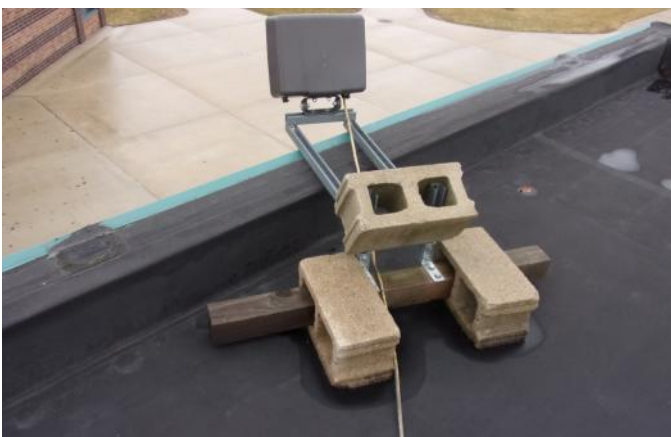
Photo 16
Anchor and Beacon
February 2023

Area B: Blocks on roof membrane without protection pads

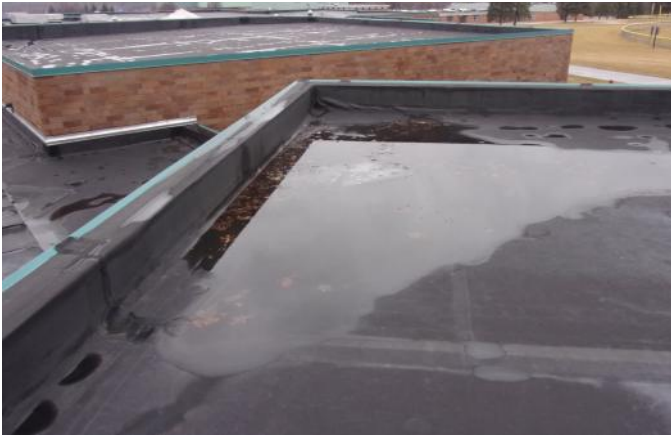
Photo 23
Anchor and Beacon
February 2023

Area E: Ponding

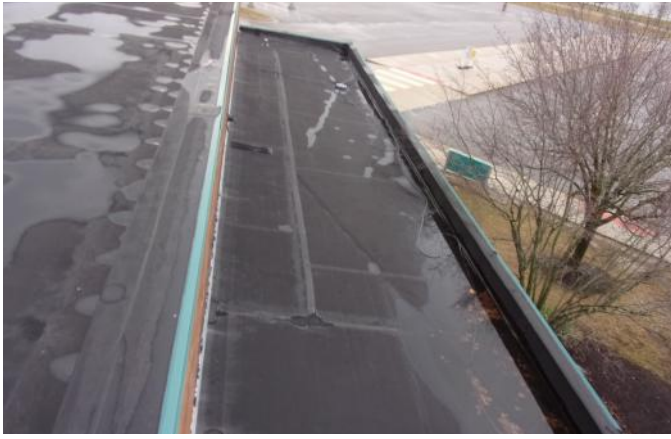
Photo 25
Anchor and Beacon
February 2023

Area F: Overview

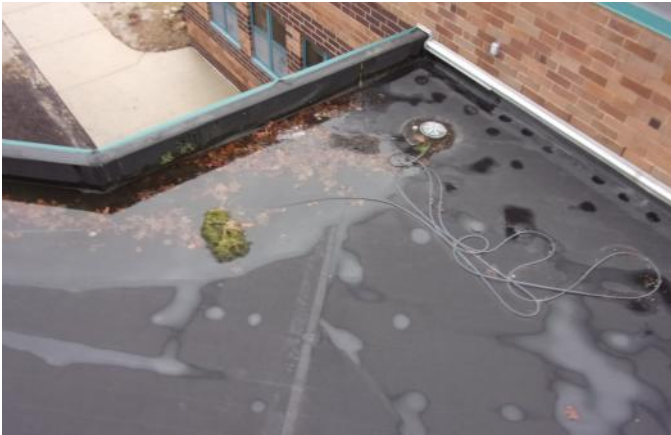
Photo 26
Anchor and Beacon
February 2023

Area F: Foreign materials on roof/leaves
in drain/ponding

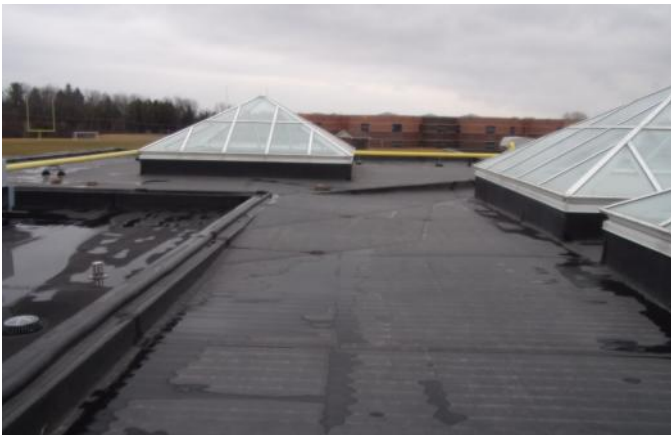
Photo 27
Anchor and Beacon
February 2023

Area G: Overview

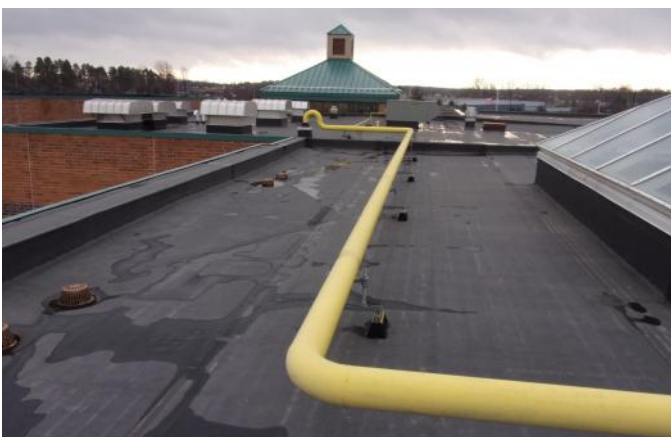
Photo 28
Anchor and Beacon
February 2023

Area G: Overview

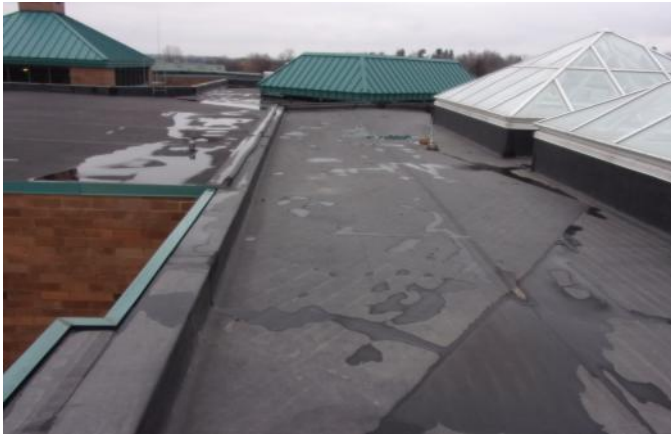
Photo 29
Anchor and Beacon
February 2023

Area H: Overview

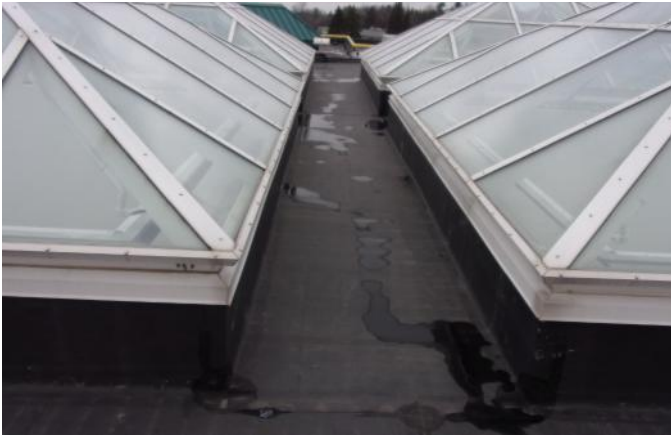
Photo 30
Anchor and Beacon
February 2023

Area H: Overview

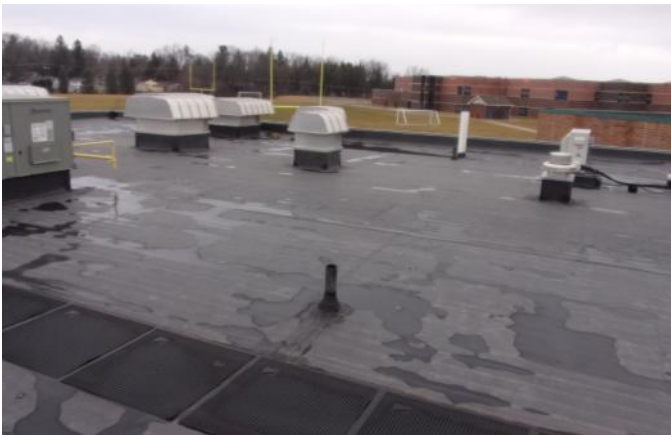
Photo 31
Anchor and Beacon
February 2023

Area I: Overview

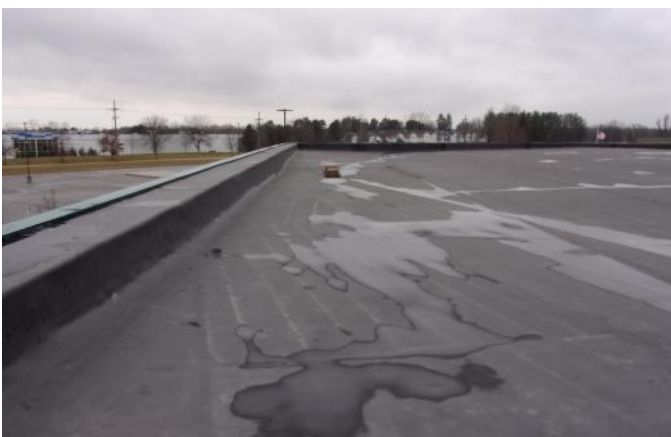
Photo 32
Anchor and Beacon
February 2023

Area J: Overview

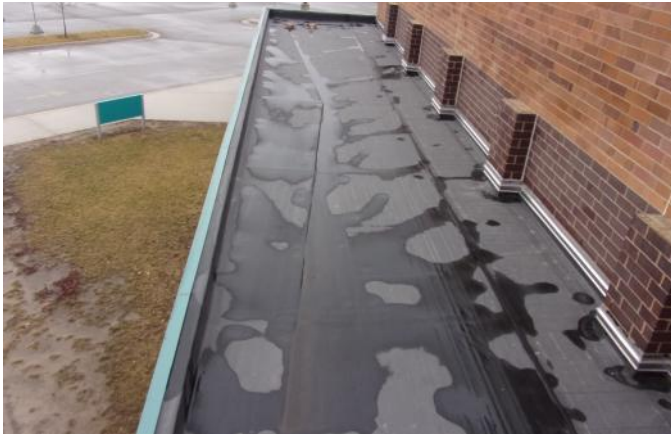
Photo 33
Anchor and Beacon
February 2023

Area K: Overview

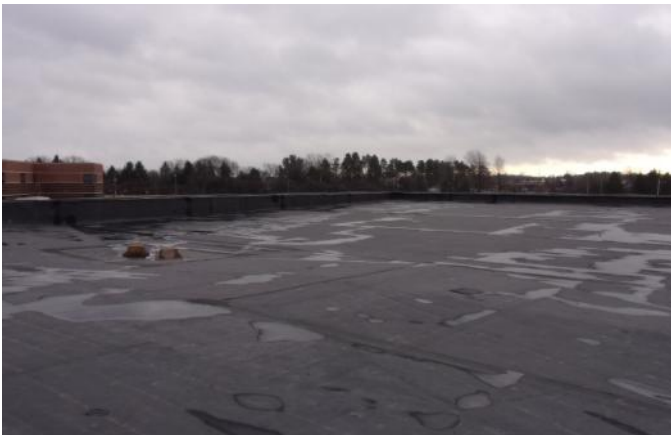
Photo 34
Anchor and Beacon
February 2023

Area L: Overview

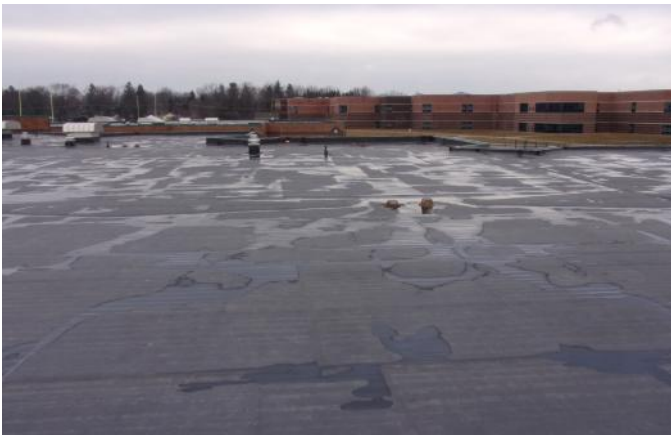
Photo 35
Anchor and Beacon
February 2023

Area M: Overview

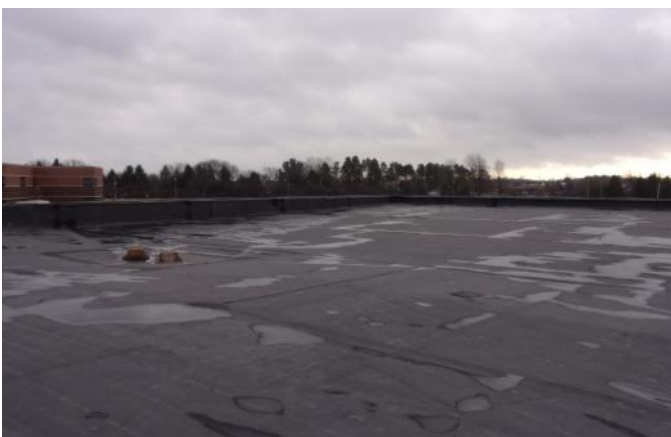
Photo 36
Anchor and Beacon
February 2023

Area M: Overview

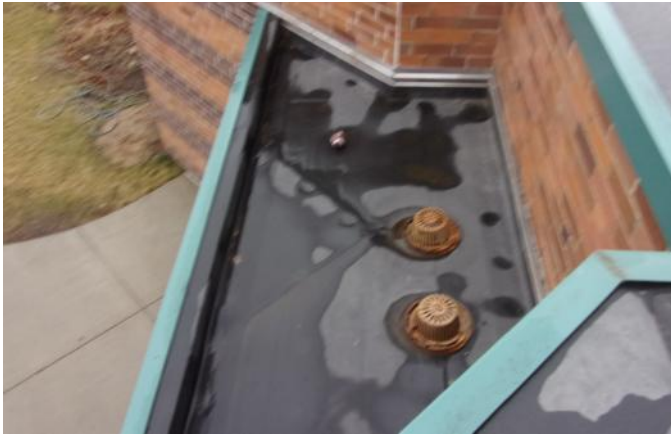
Photo 37
Anchor and Beacon
February 2023

Area M1: Overview

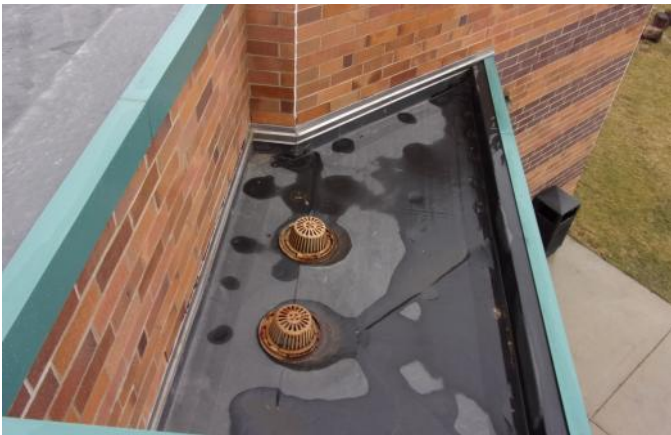
Photo 38
Anchor and Beacon
February 2023

Area M4: Overview

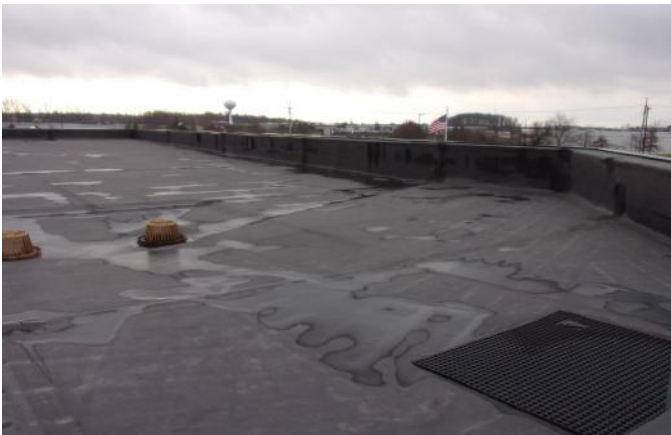
Photo 39
Anchor and Beacon
February 2023

Area N: Overview

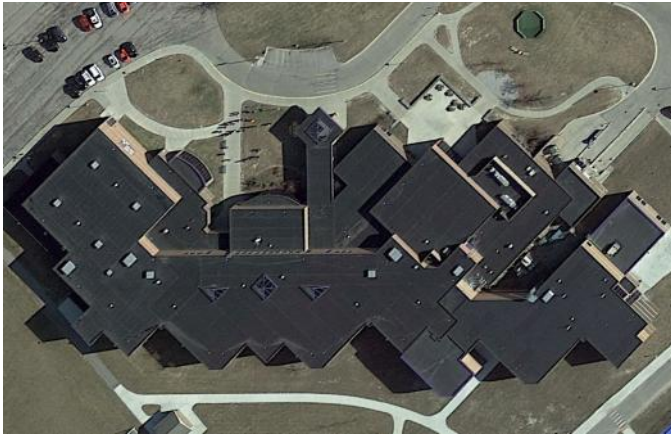
Photo 1
Mill Creek MS
February 2023

Mill Creek Middle School Aerial View

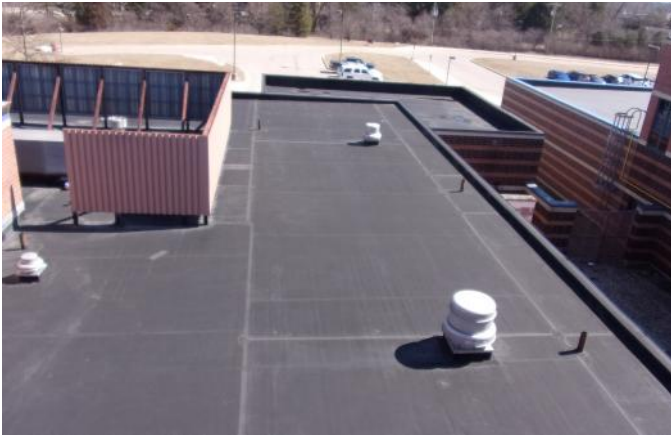
Photo 2
Mill Creek MS
February 2023

Area A: Overview

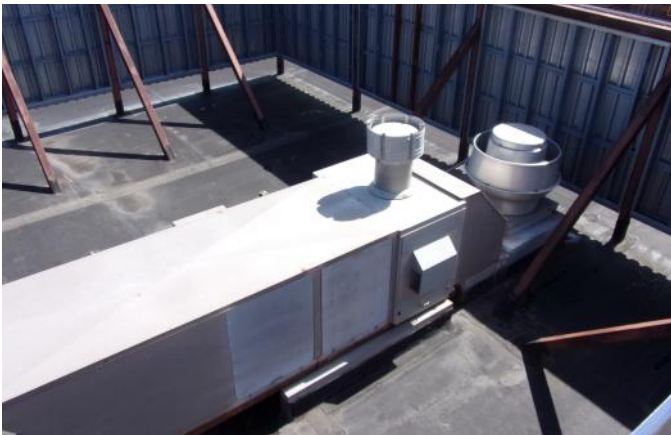
Photo 3
Mill Creek MS
February 2023

Area A: Overview

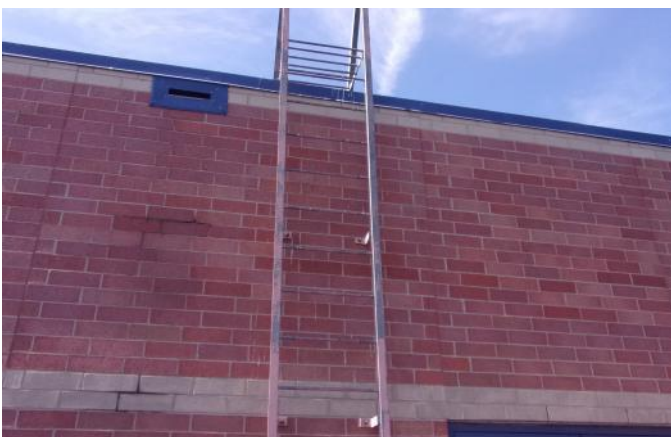
Photo 4
Mill Creek MS
February 2023

Area A: Unsecured ladder

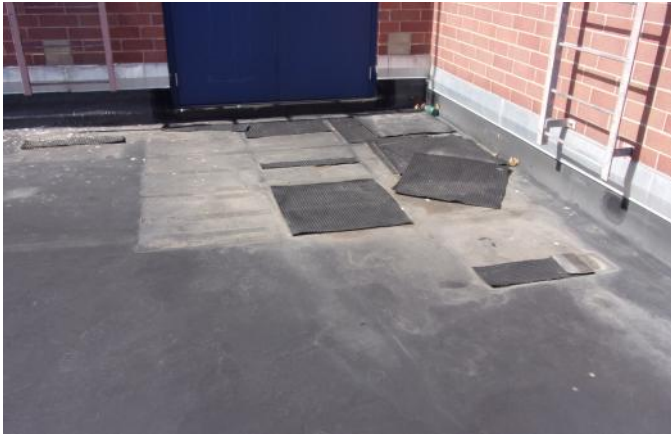
Photo 5
Mill Creek MS
February 2023

Area A: Displaced walk pads

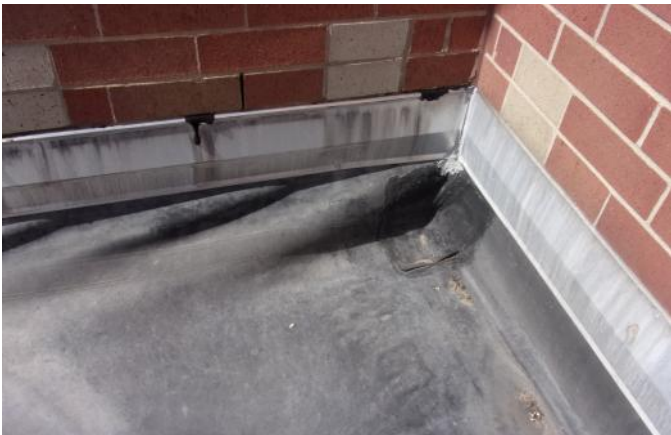
Photo 6
Mill Creek MS
February 2023

Area A: Delaminated base flashing/diagonal wrinkles

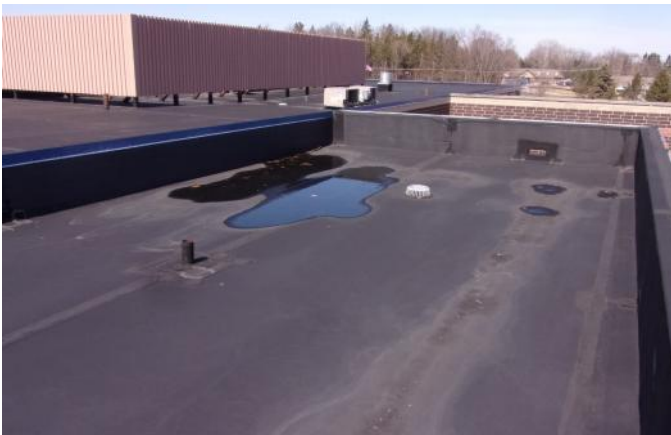
Photo 7
Mill Creek MS
February 2023

Area B: Overview

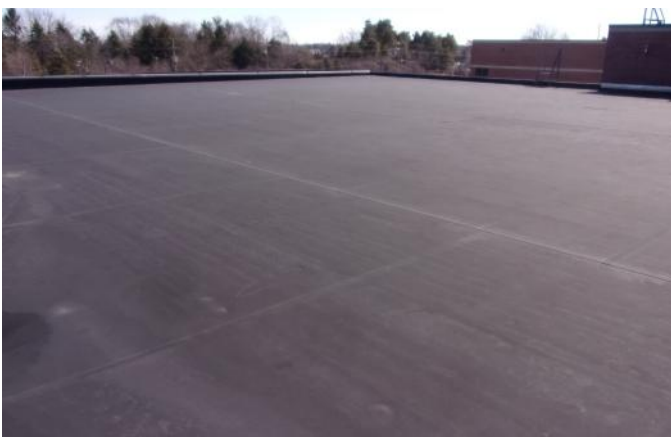
Photo 8
Mill Creek MS
February 2023

Area C: Overview

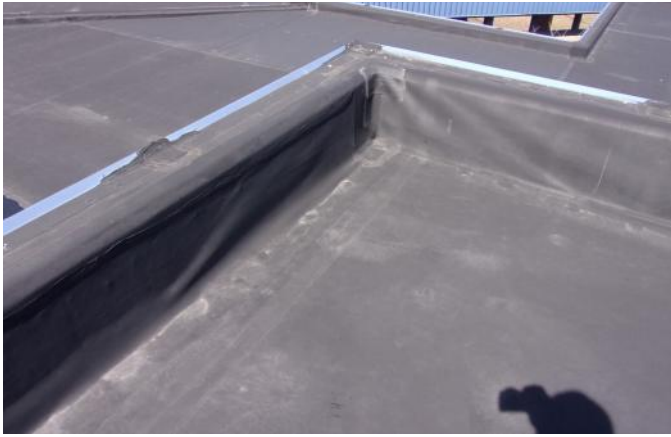
Photo 9
Mill Creek MS
February 2023

Area C: Diagonal wrinkles on base flashing

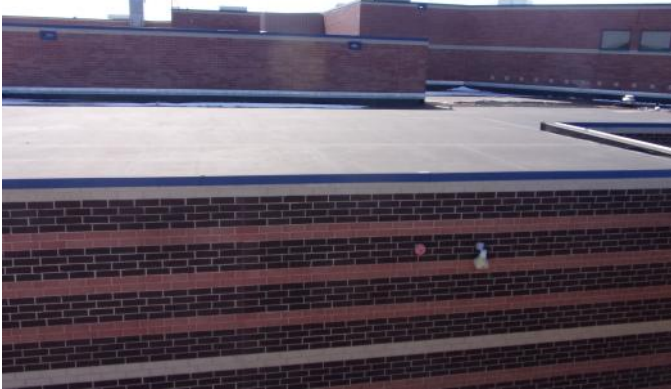
Photo 10
Mill Creek MS
February 2023

Area D: Overview

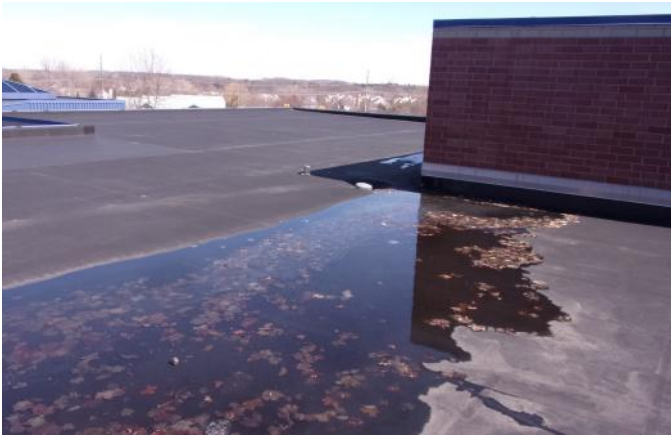
Photo 11
Mill Creek MS
February 2023

Area D: Overview

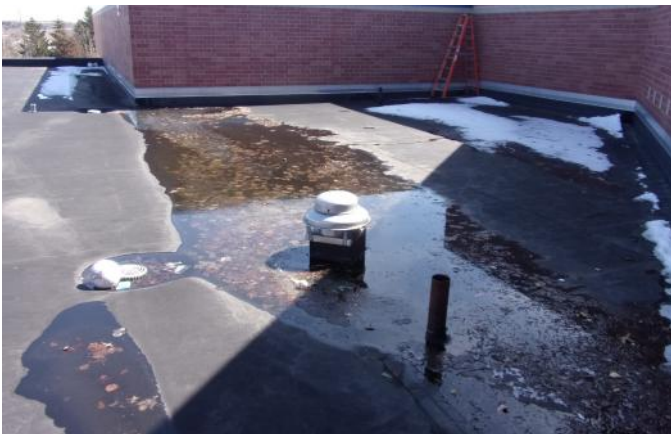
Photo 12
Mill Creek MS
February 2023

Area D: Ponding

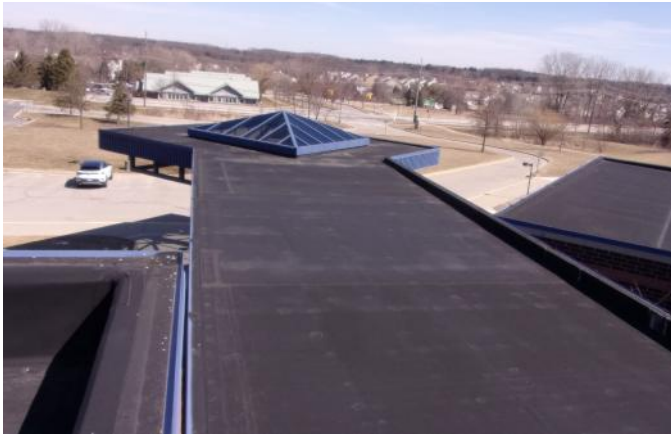
Photo 13
Mill Creek MS
February 2023

Area E: Overview

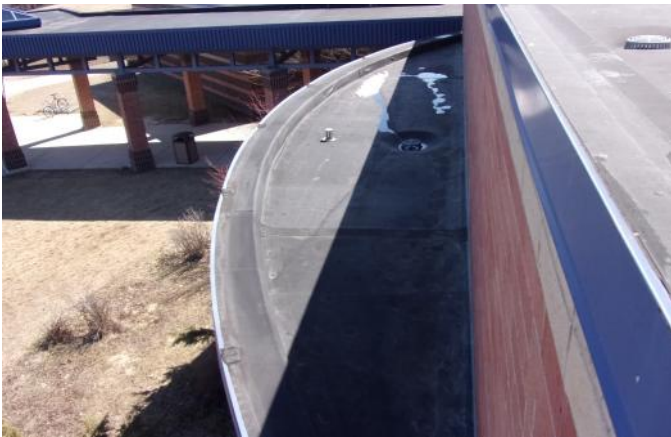
Photo 14
Mill Creek MS
February 2023

Area F: Overview

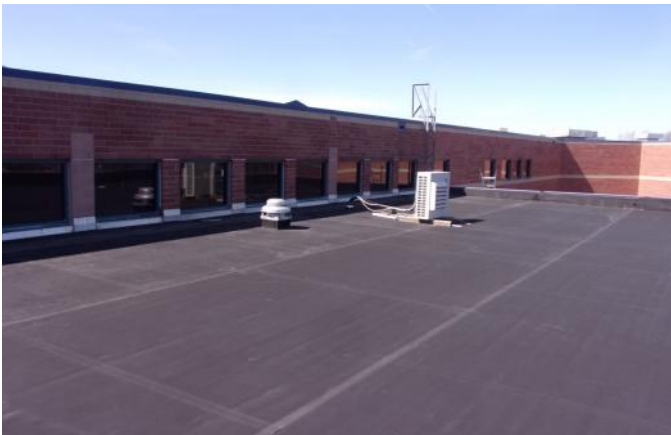
Photo 15
Mill Creek MS
February 2023

Area G: Overview

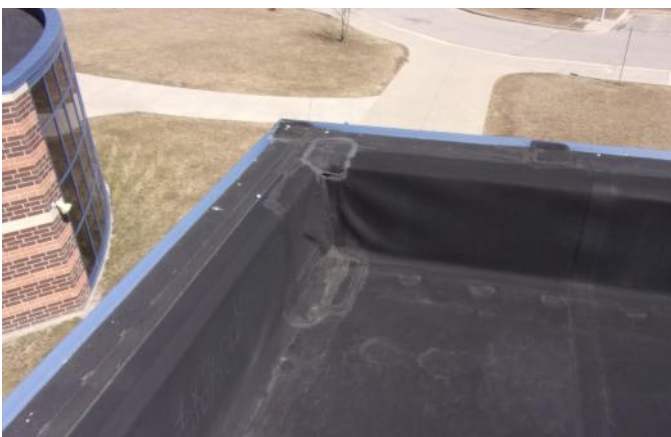
Photo 16
Mill Creek MS
February 2023

Area G: Diagonal wrinkles on base
flashing

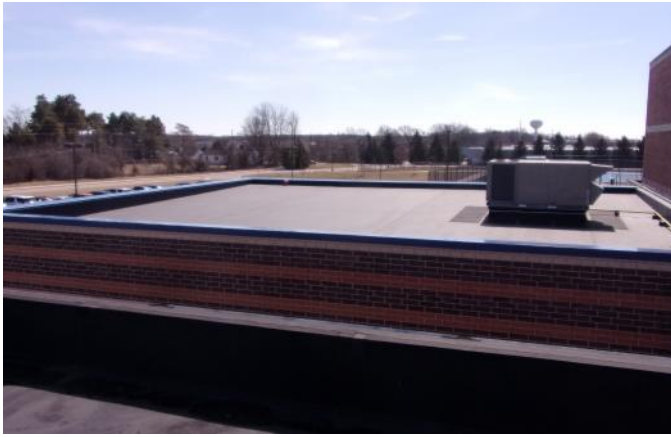
Photo 17
Mill Creek MS
February 2023

Area H2: Overview

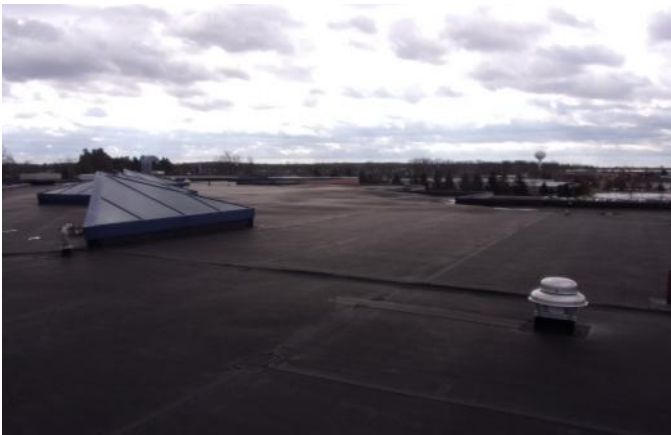
Photo 18
Mill Creek MS
February 2023

Area J: Overview/disbonded EPDM
membrane prior to emergency
replacement

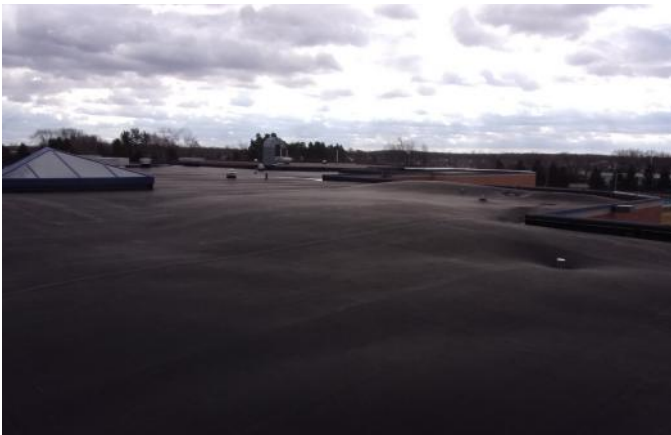
Photo 19
Mill Creek MS
February 2023

Area J: Overview/disbonded EPDM
membrane prior to emergency
replacement

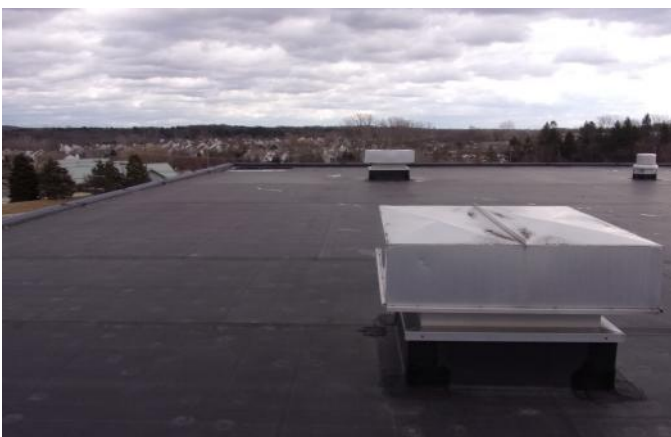
Photo 20
Mill Creek MS
February 2023

Area K: Overview

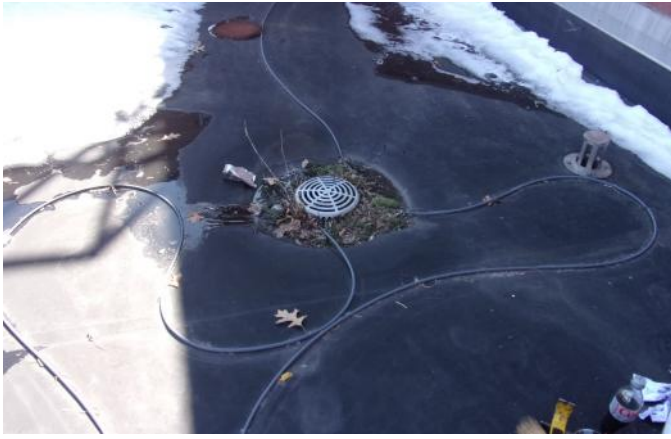
Photo 21
Mill Creek MS
February 2023

Area L: Foreign materials on roof -
blocked drain

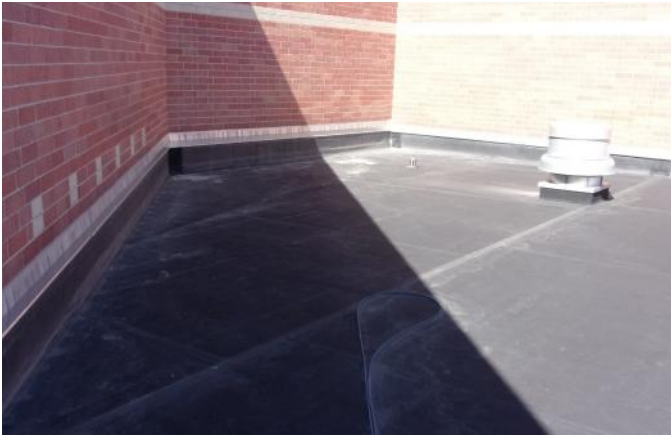
Photo 22
Mill Creek MS
February 2023

Area M: Overview

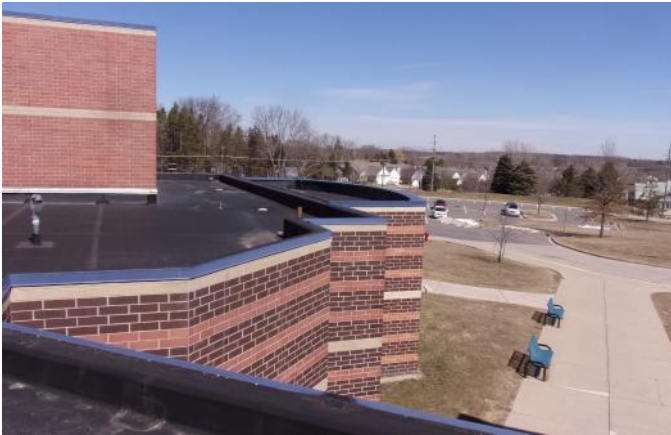
Photo 23
Mill Creek MS
February 2023

Area M: Overview

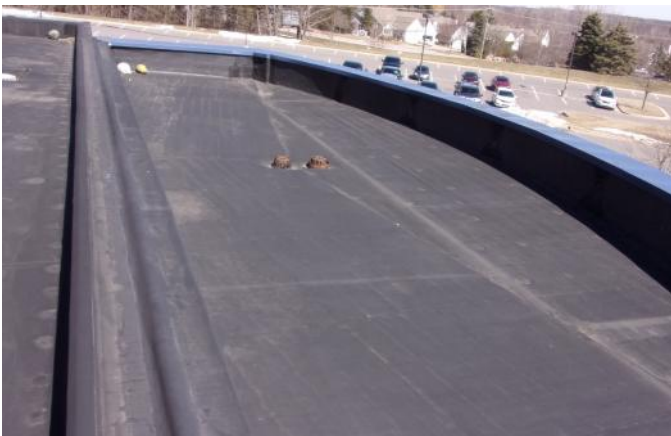
Photo 24
Mill Creek MS
February 2023

Area N: Overview

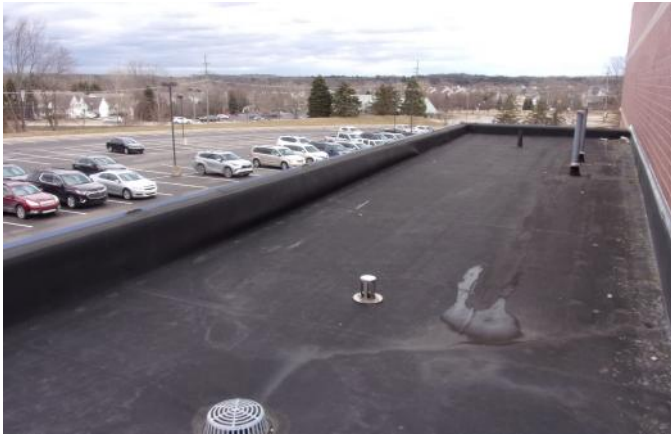
Photo 25
Mill Creek MS
February 2023

Area P: Overview

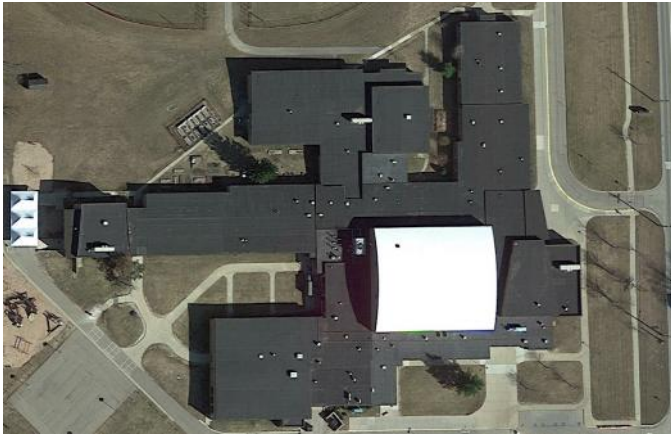
Photo 1
Creekside
February 2023

Creekside Elementary School Aerial View

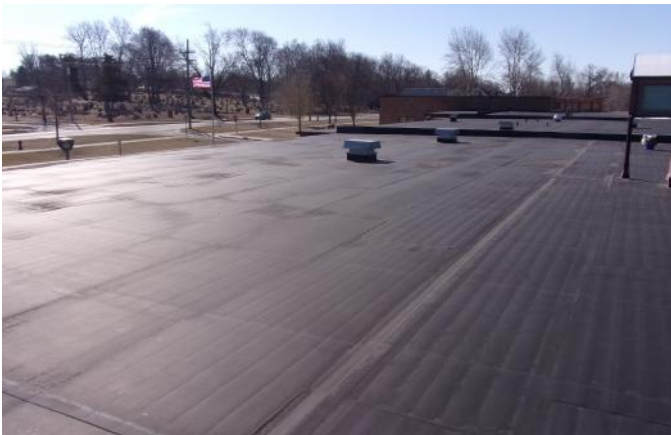
Photo 2
Creekside
February 2023

Area A: Overview

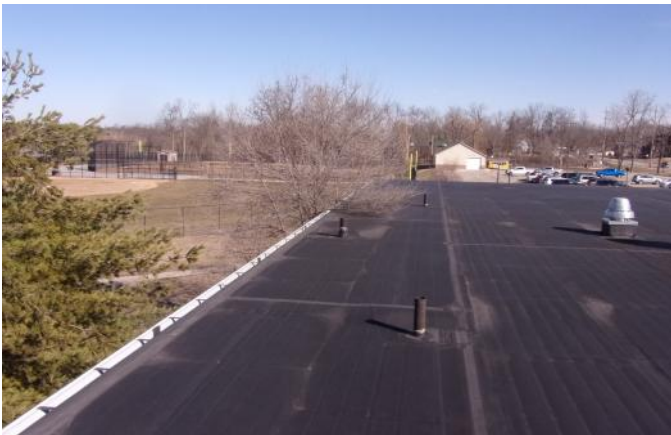
Photo 3
Creekside
February 2023

Area A: Overhanging branches

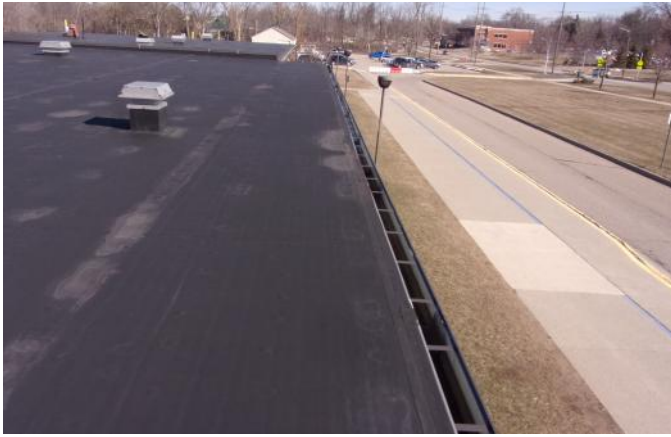
Photo 5
Creekside
February 2023

Area B: Overview

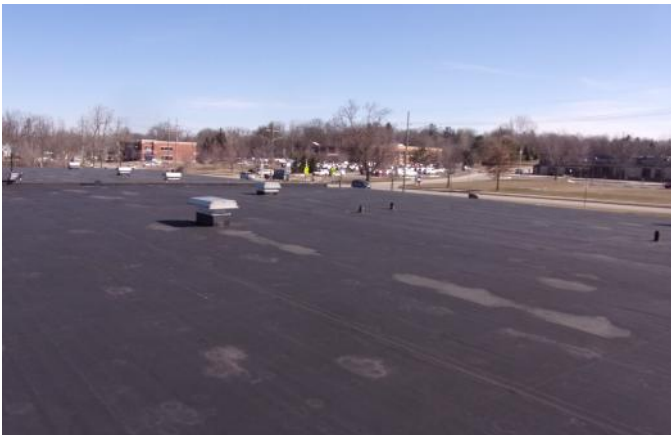
Photo 6
Creekside
February 2023

Area B: Overview

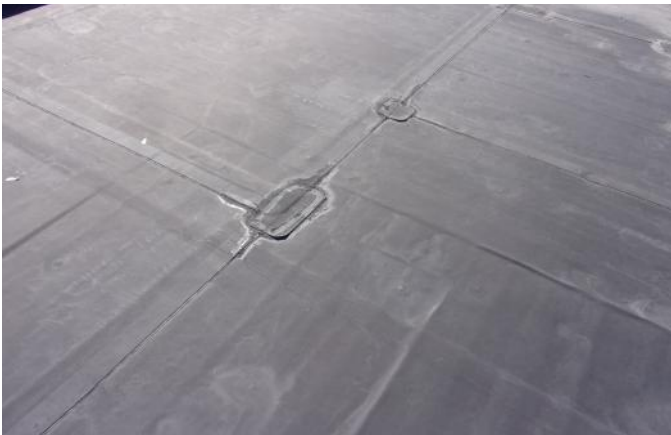
Photo 7
Creekside
February 2023

Area B: Loose seams

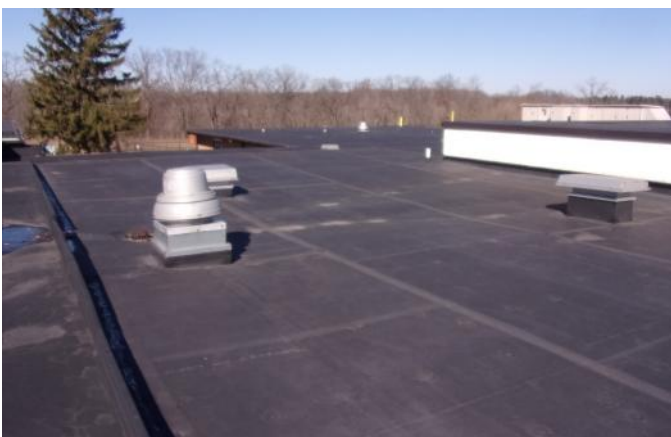
Photo 8
Creekside
February 2023

Area C: Overview

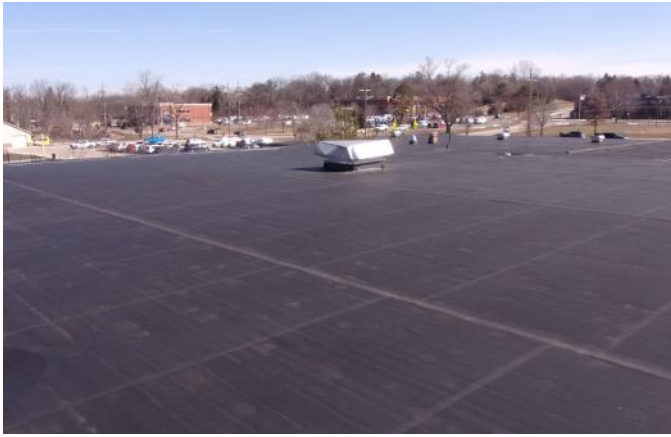
Photo 9
Creekside
February 2023

Area D: Overview

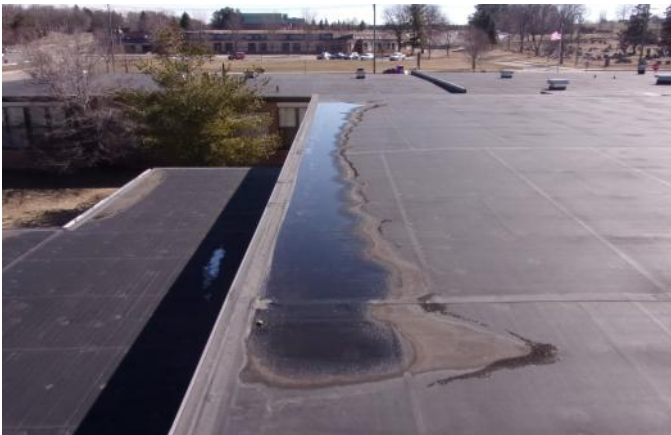
Photo 10
Creekside
February 2023

Area D: Ponding

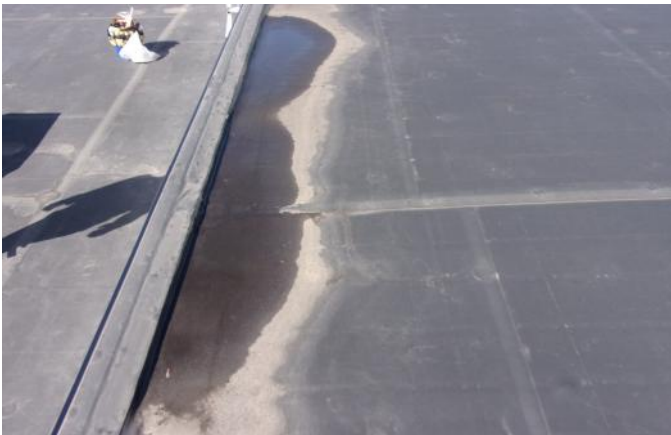
Photo 11
Creekside
February 2023

Area D: Ponding
