DEXTER COMMUNITY SCHOOLS

2023 ROOF EVALUATION

RTA PROJECT NO. 22-106

APRIL 7, 2023

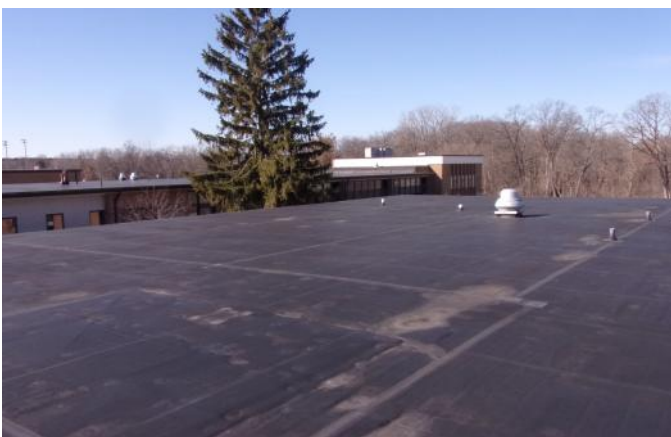
Photo 12
Creekside
February 2023

Area E: Overview

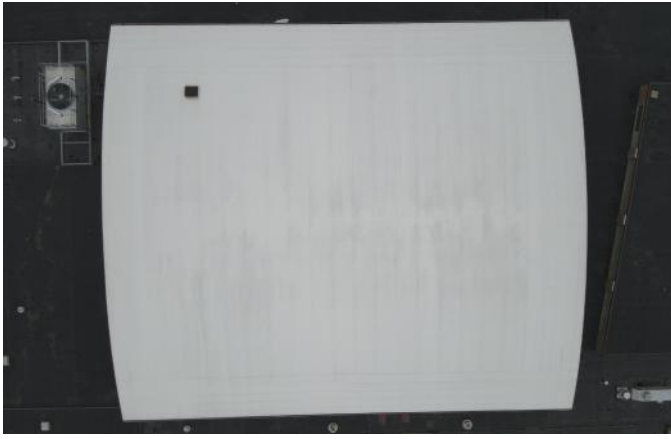
Photo 13
Creekside
February 2023

Area F: Overview

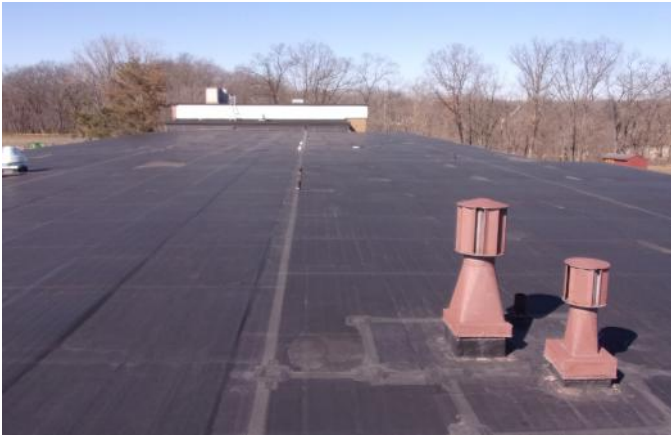
Photo 14
Creekside
February 2023

Area G: Overview

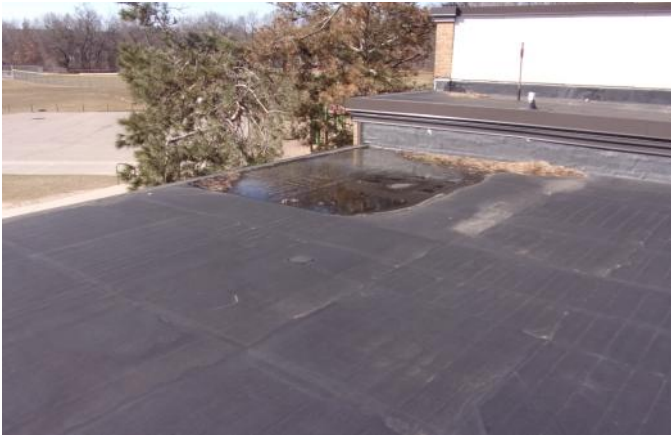
Photo 15
Creekside
February 2023

Area G: Ponding

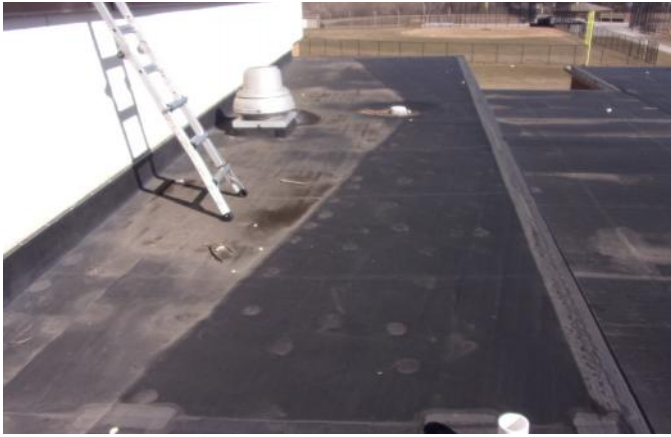
Photo 17
Creekside
February 2023

Area H: Overview

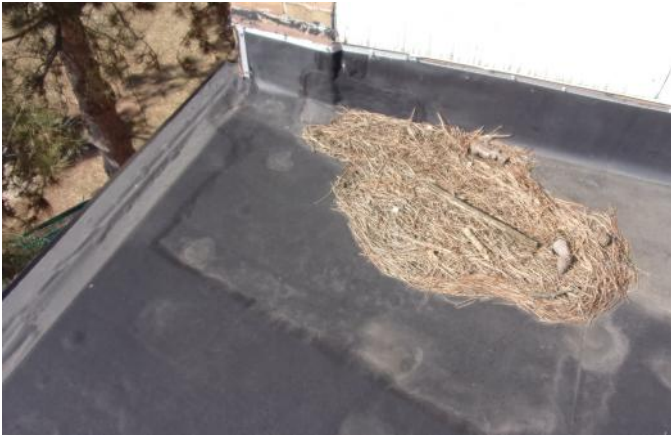
Photo 18
Creekside
February 2023

Area H: Debris/vegetation

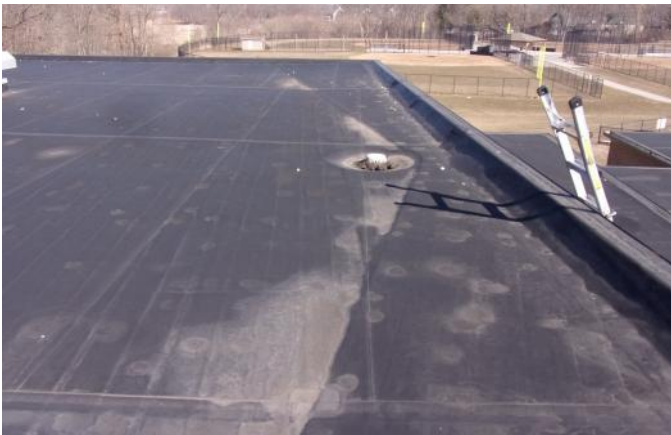
Photo 19
Creekside
February 2023

Area I: Overview

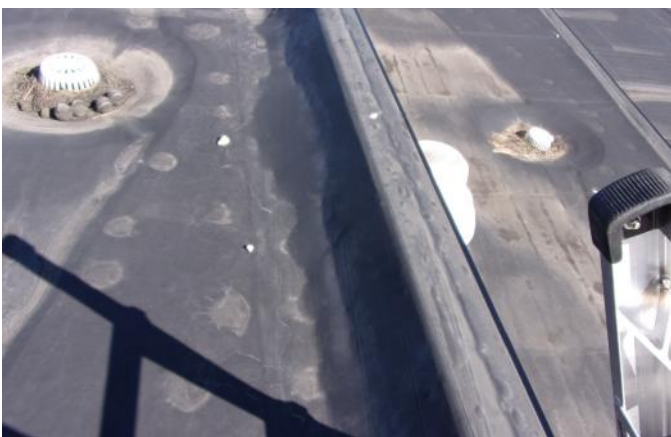
Photo 20
Creekside
February 2023

Areas I and H: Debris/tennis balls in drains

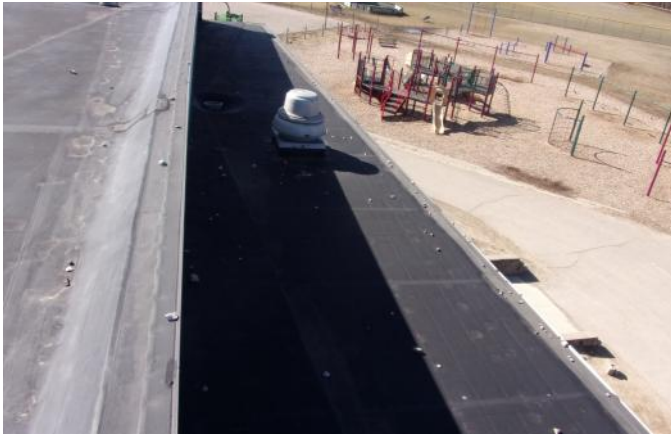
Photo 21
Creekside
February 2023

Area J: Overview

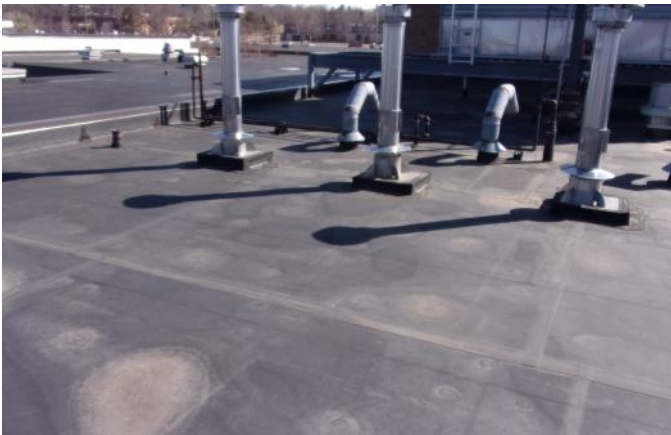
Photo 22
Creekside
February 2023

Area K: Overview

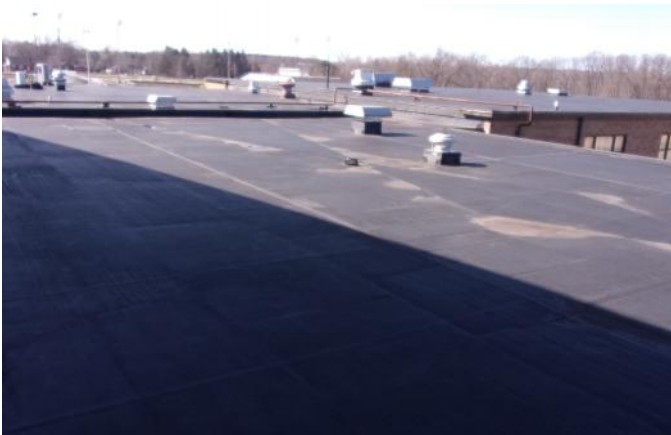
Photo 23
Creekside
February 2023

Area L: Overview

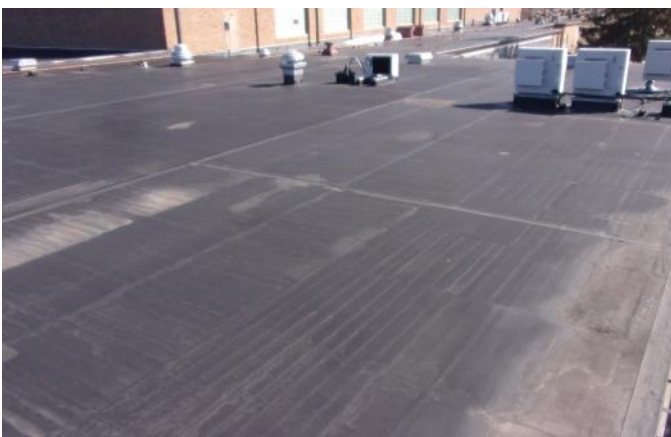
Photo 24
Creekside
February 2023

Area M: Overview

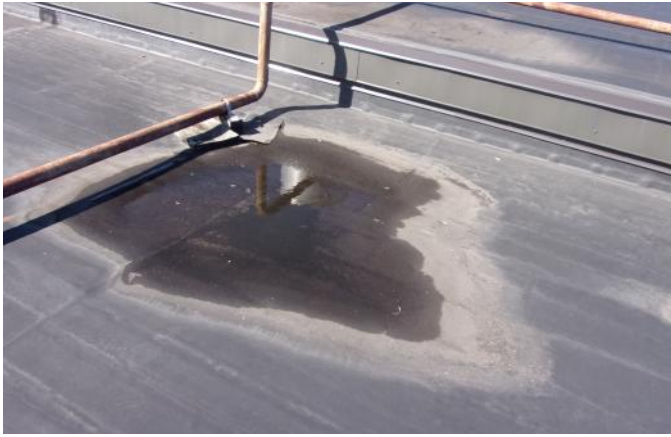
Photo 25
Creekside
February 2023

Area M: Ponding

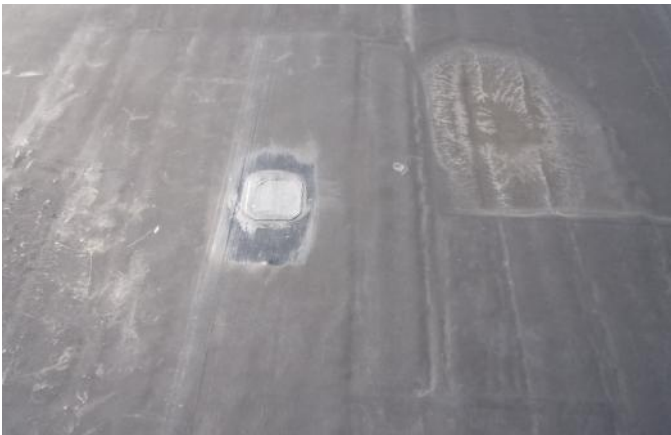
Photo 26
Creekside
February 2023

Area M: Repair

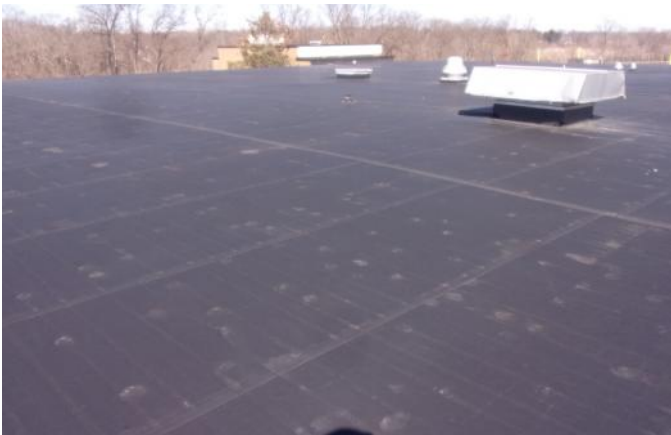
Photo 27
Creekside
February 2023

Area N: Overview

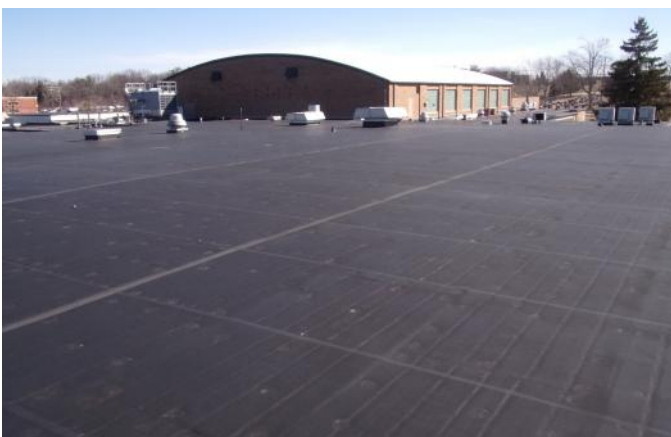
Photo 28
Creekside
February 2023

Area N: Overview

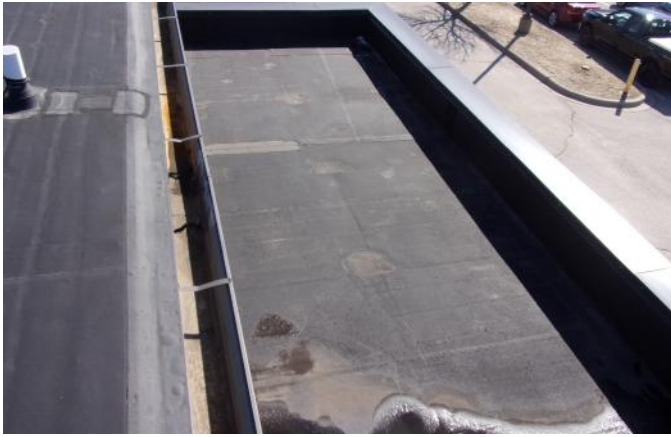
Photo 29
Creekside
February 2023

Area O: Overview

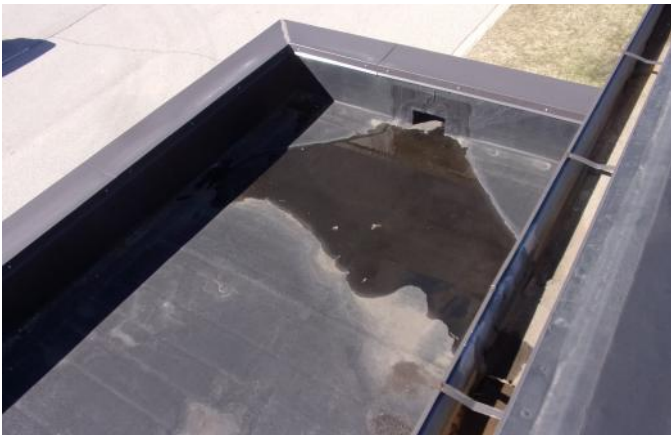
Photo 30
Creekside
February 2023

Area O: Ponding

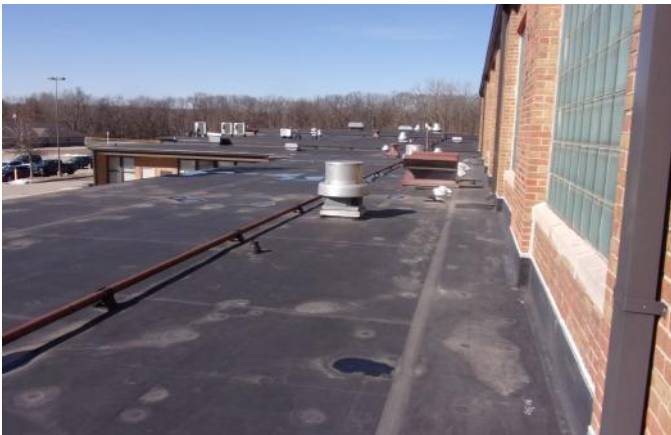
Photo 31
Creekside
February 2023

Area P: Overview

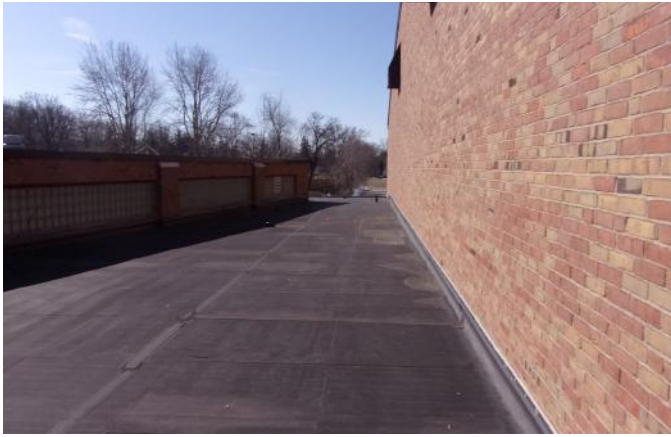
Photo 33
Creekside
February 2023

Area Q: Overview

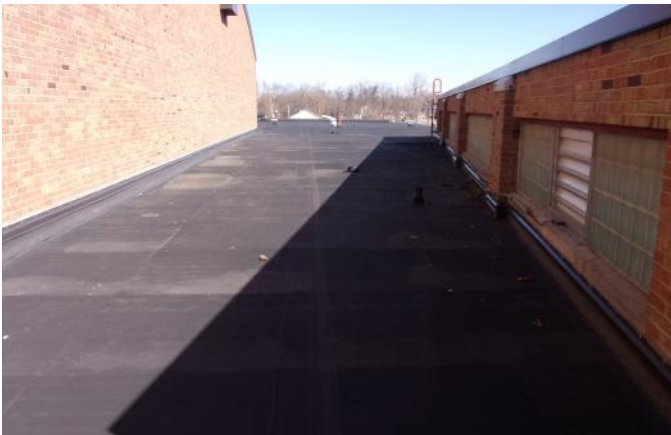
Photo 34
Creekside
February 2023

Area O: Overview

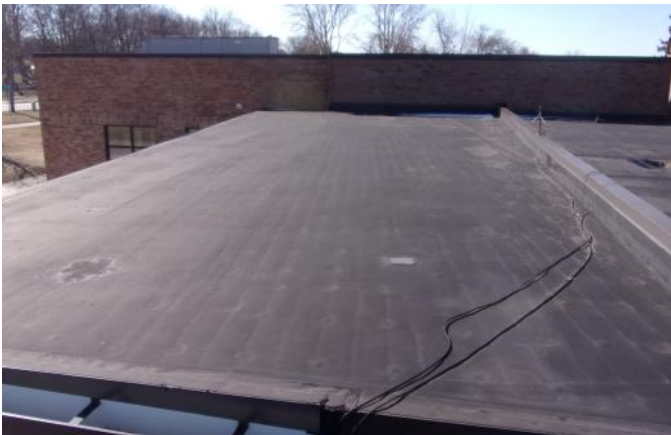
Photo 35
Creekside
February 2023

Area R: Overview

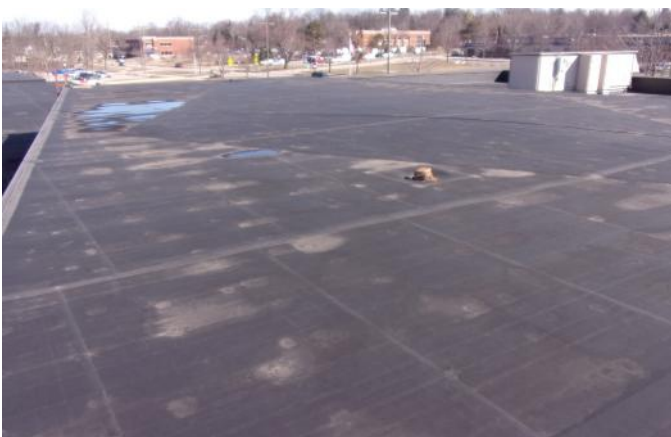
Photo 36
Creekside
February 2023

Area S: Overview

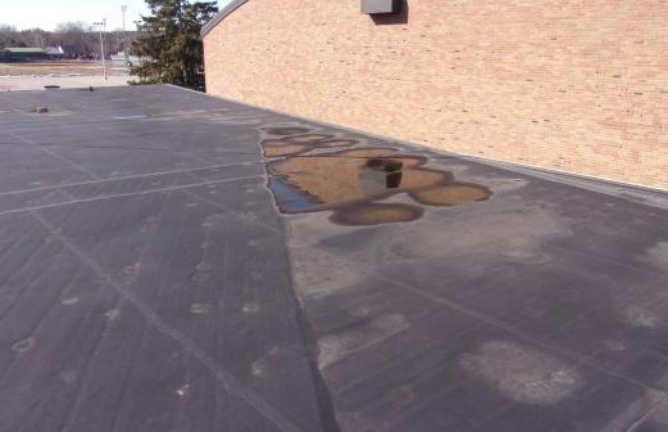
Photo 37
Creekside
February 2023

Area S: Ponding

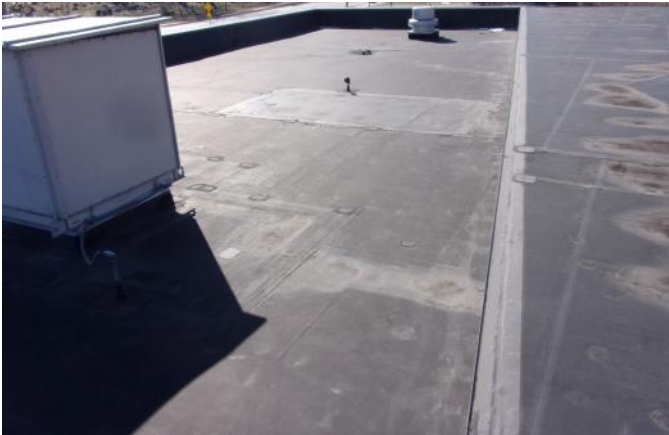
Photo 38
Creekside
February 2023

Area T: Overview

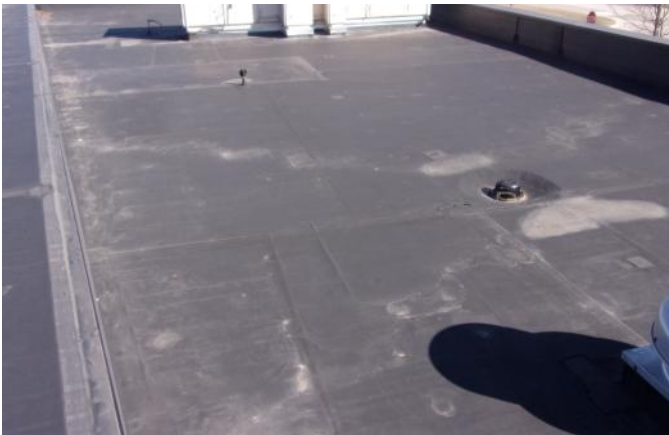
Photo 39
Creekside
February 2023

Area T: Overview

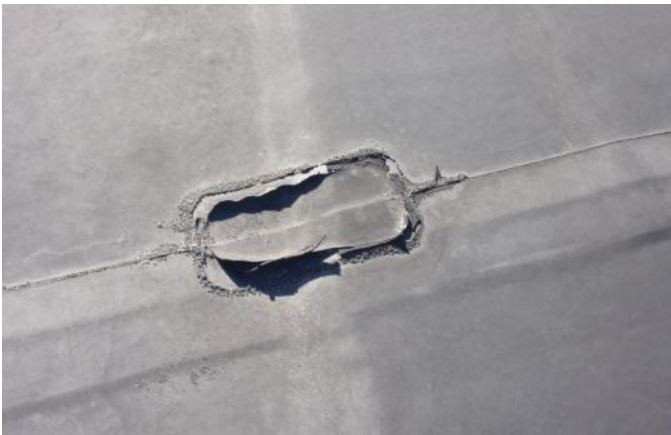
Photo 3
Bates
February 2023

Area A: Failed lap sealant

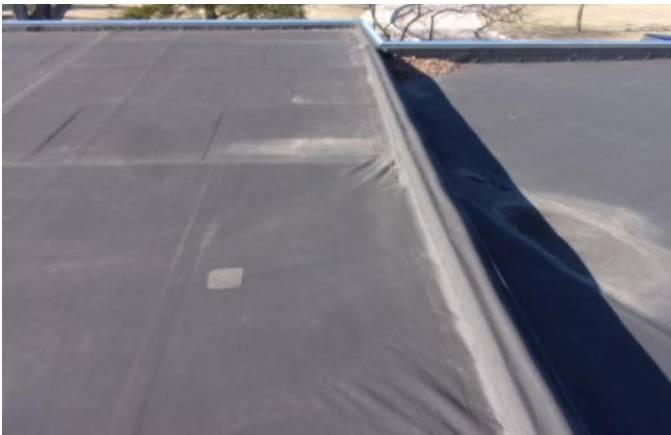
Photo 6
Bates
February 2023

Area A: Disbonded EPDM membrane

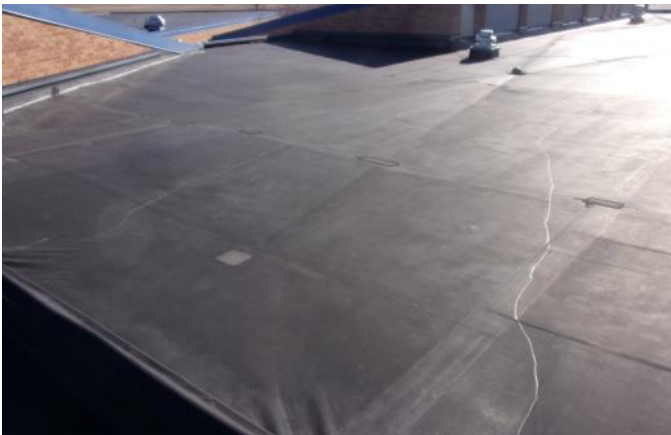
Photo 7
Bates
February 2023

Area A: Disbonded EPDM membrane

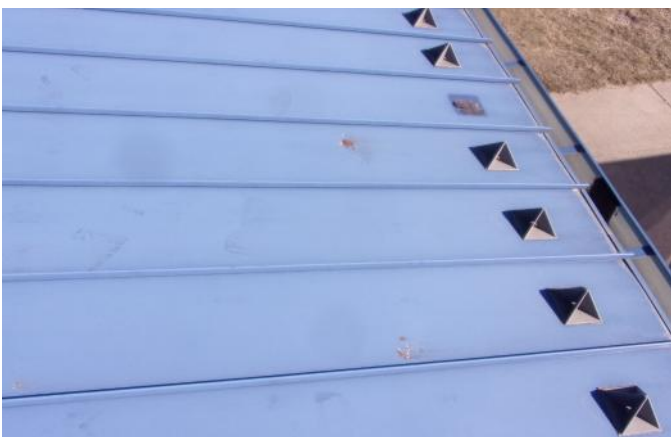
Photo 12
Bates
February 2023

Area C: Minor rust/pitting on sheet metal panels

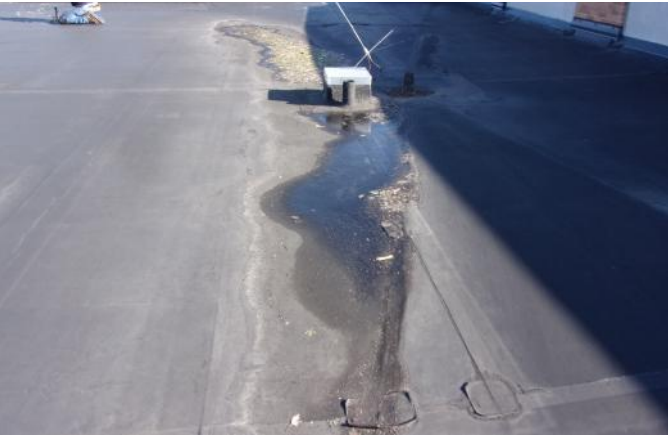
Photo 15
Bates
February 2023

Area D: Debris/vegetation - ponding

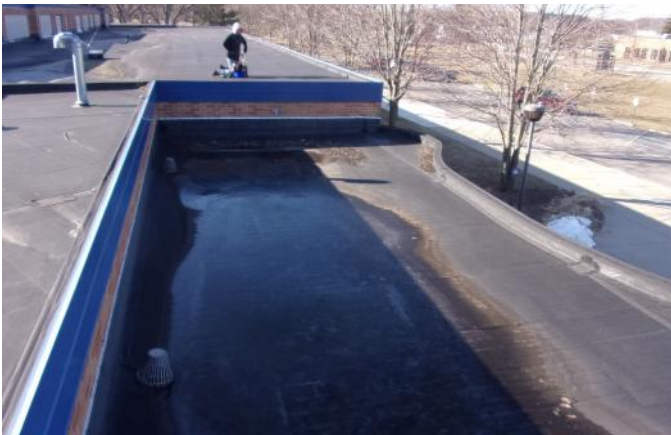
Photo 18
Bates
February 2023

Area E: Ponding

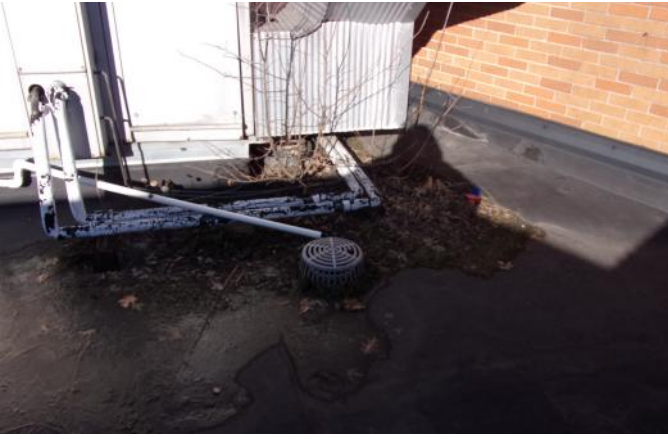
Photo 21
Bates
February 2023

Area F: Debris/vegetation/ponding

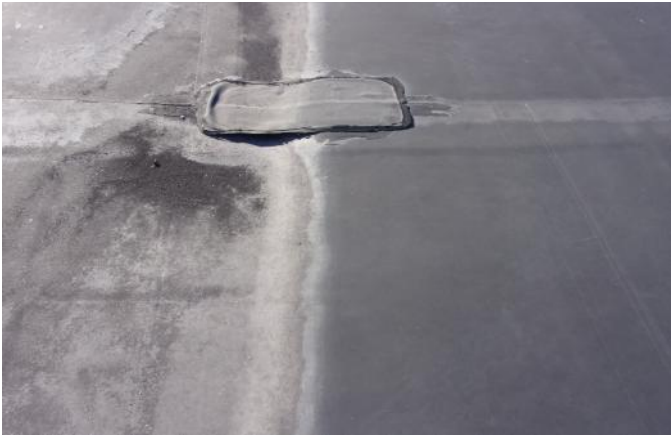
Photo 22
Bates
February 2023

Area F: Failed lap sealant

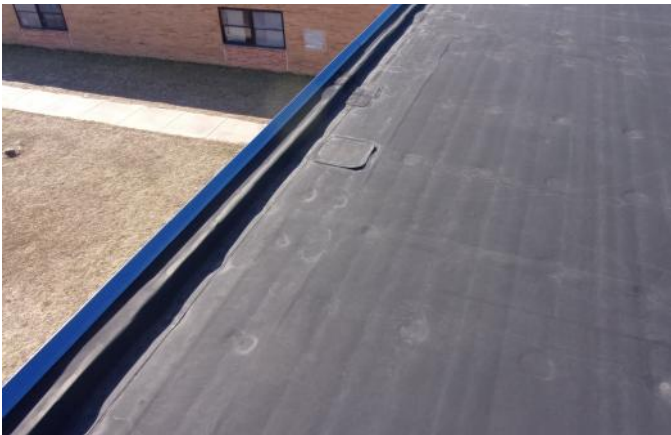
Photo 27
Bates
February 2023

Area H: Loose seam/failed lap sealant

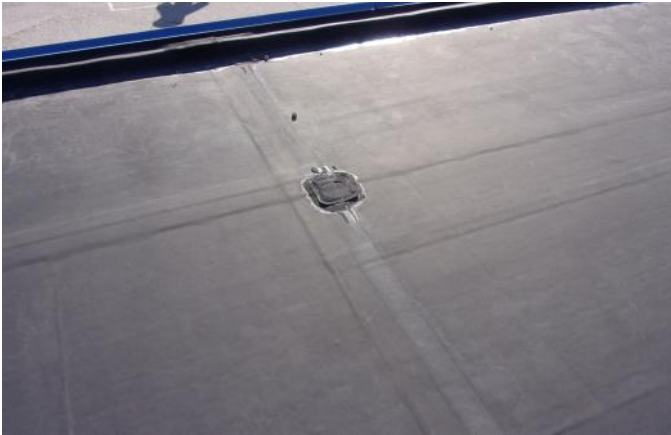
Photo 34
Bates
February 2023

Area L: Loose seam/failed lap sealant

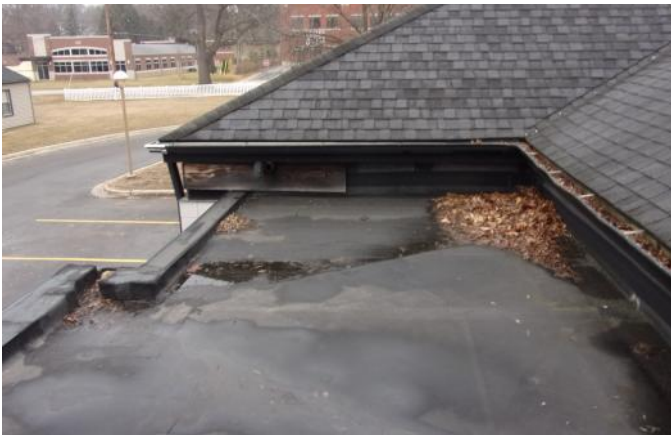
Photo 3
Jenkins
February 2023

Area B: Accumulated leaves impeding
drainage

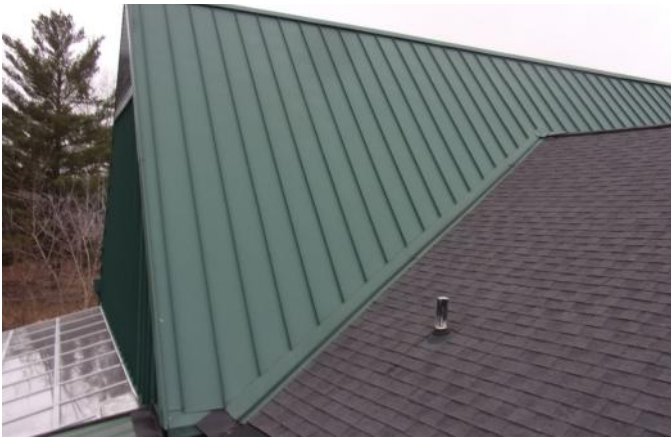
Photo 9
Jenkins
February 2023

Area C: Rust/corrosion on counterflashing

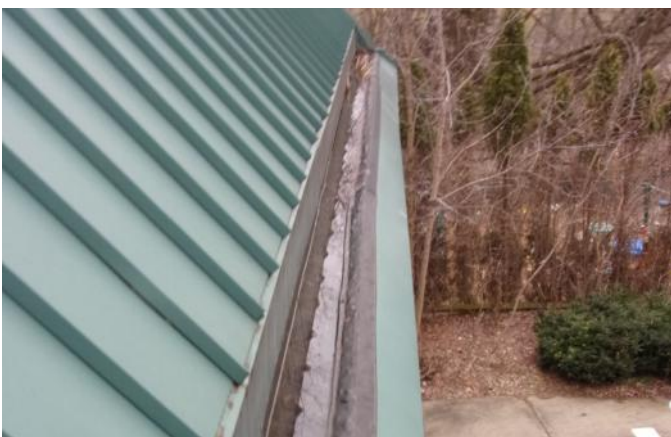
Photo 11
Jenkins
February 2023

Area D: Damaged sheet metal flashing

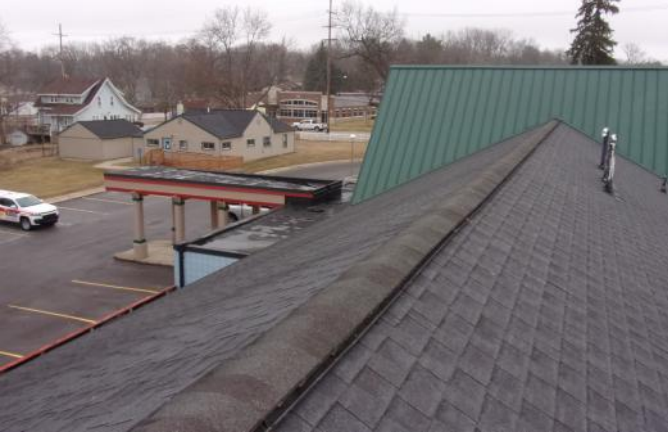
Photo 12
Jenkins
February 2023

Area D: Leaves/debris in internal gutter
impeding drainage

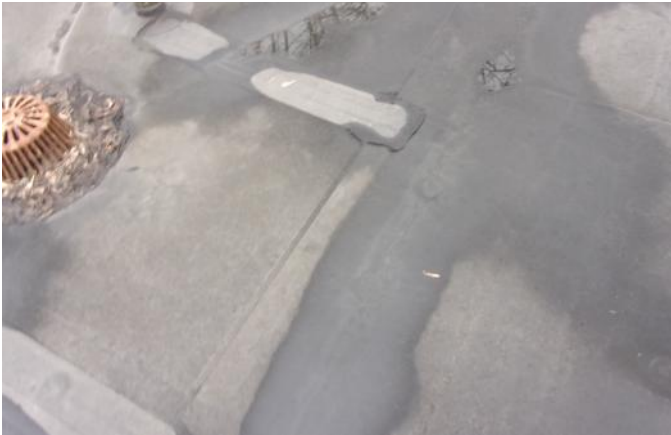
Photo 17
Jenkins
February 2023

Area H: Leaves/branches on the membrane

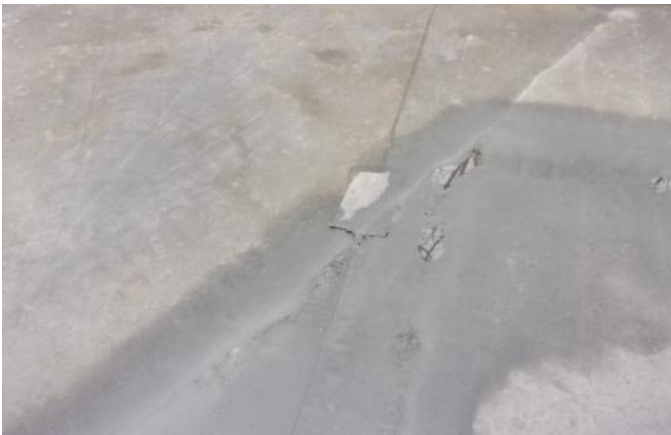
Photo 18
Jenkins
February 2023

Area H: Repaired laps/leaves in drain

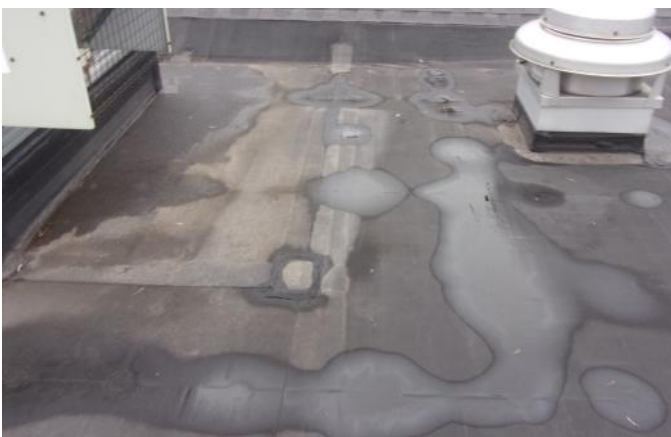
Photo 19
Jenkins
February 2023

Area H: Loose seams

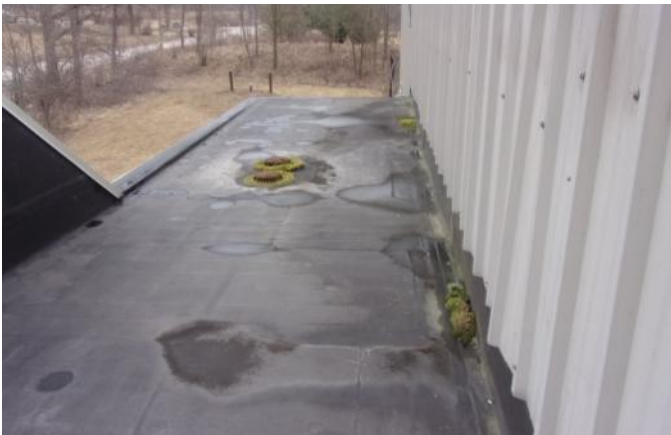
Photo 6
Transportation
February 2023

Area B: Vegetation impeding drainage

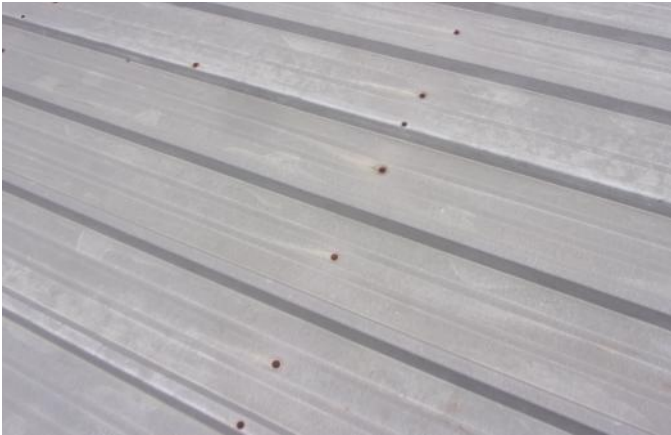
Photo 10
Transportation
February 2023

Area C: Rusted fasteners

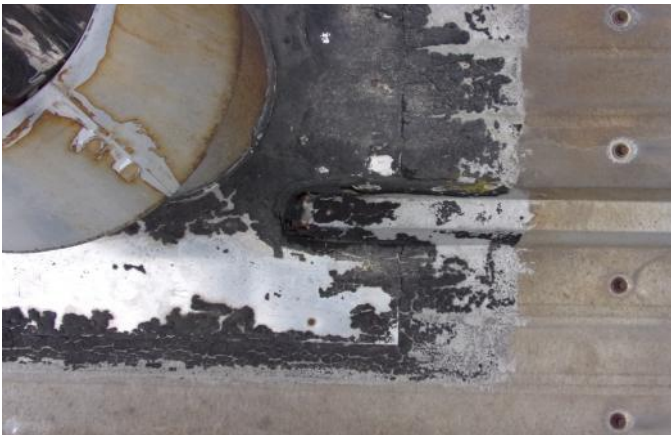
Photo 11
Transportation
February 2023

Area C: Deteriorated sealant

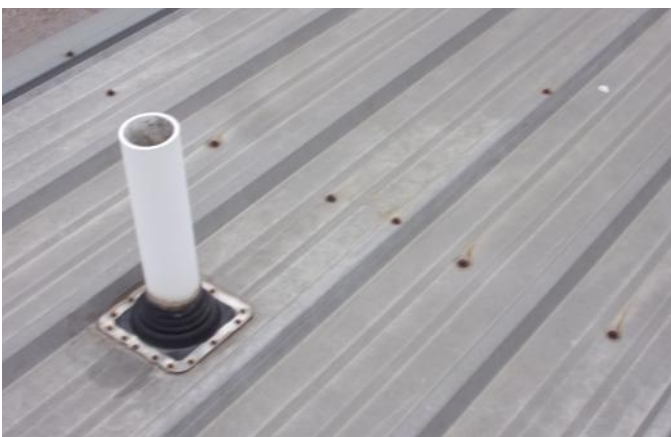
Photo 12
Transportation
February 2023

Area C: Rusted fasteners

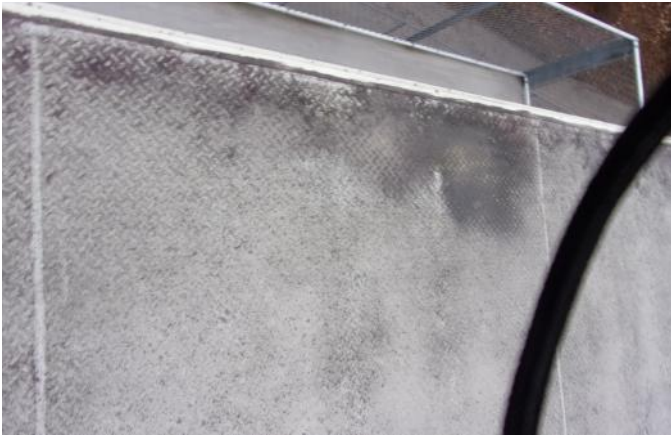
Photo 3
Al Ritt Field
February 2023

Press Box Roof: Surface worn coating

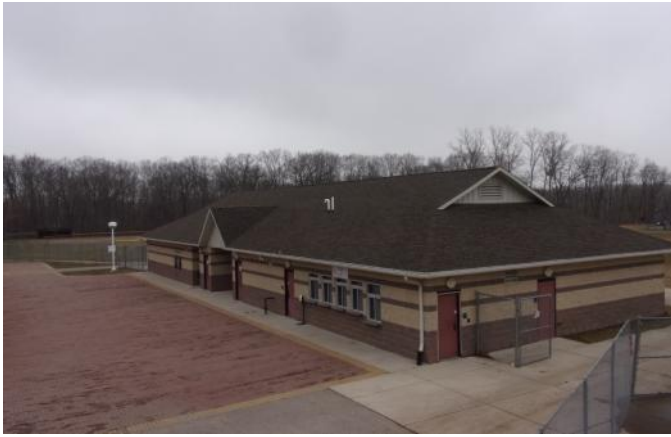
Photo 4
Al Ritt Field
February 2023

Press Box Roof: Improperly flashed penetrations

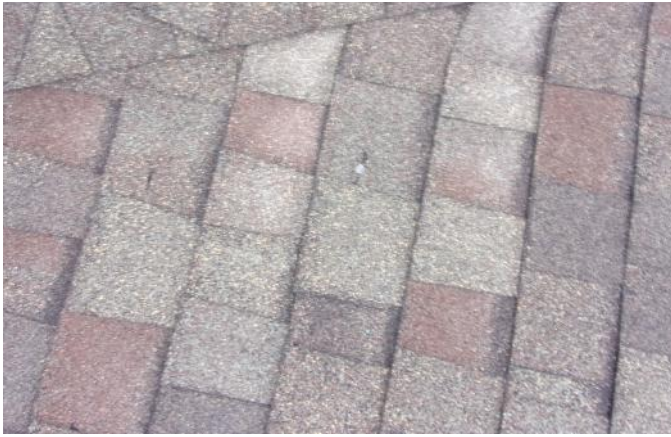
Photo 8
Al Ritt Field
February 2023

Concession Building: Mineral granules in gutter

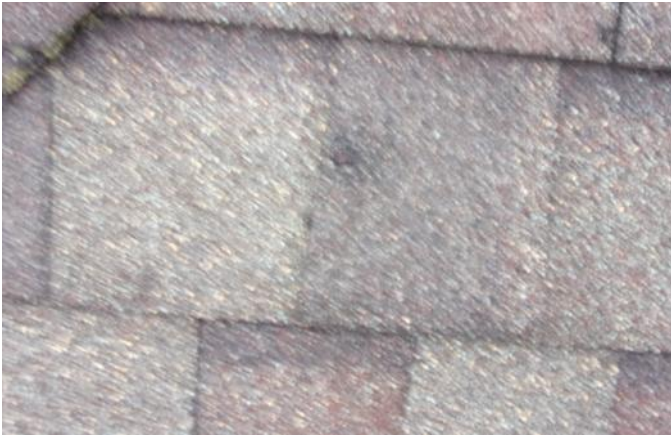
Photo 9
Al Ritt Field
February 2023

Concession Building: Exposed fastener -
nail pop

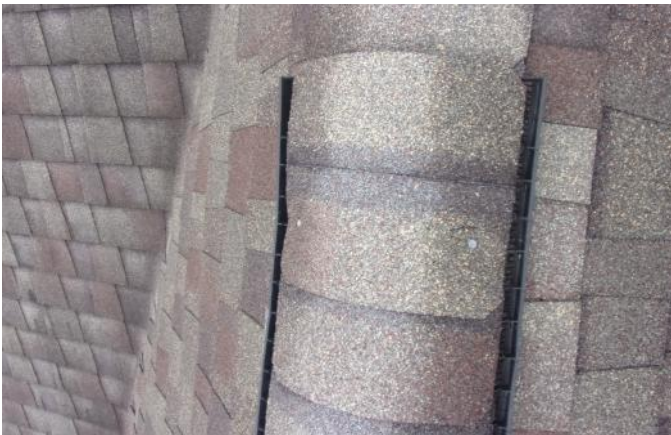
Photo 10
Al Ritt Field
February 2023

Concession Building: Exposed fastener -
nail pop

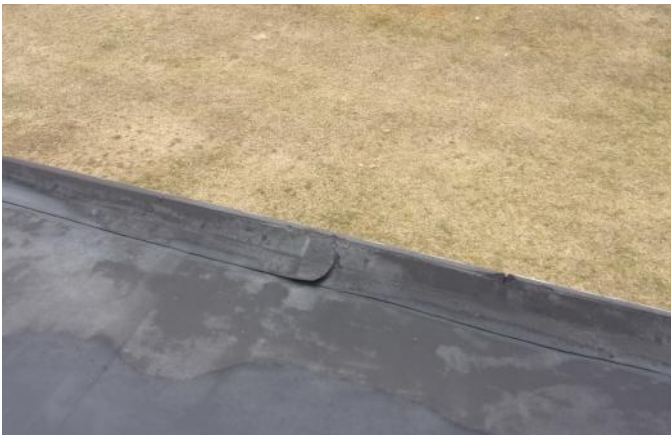
Photo 14
Al Ritt Field
February 2023

Equipment Building: Loose seams

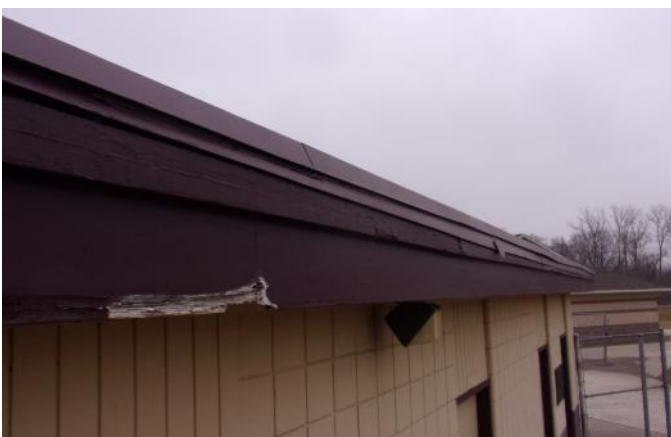
Photo 15
Al Ritt Field
February 2023

Equipment Building: Loose seams
